Task 13 Performance, Operation and Reliability of Photovoltaic Systems

PV Failure Fact Sheets (PVFS) 2023

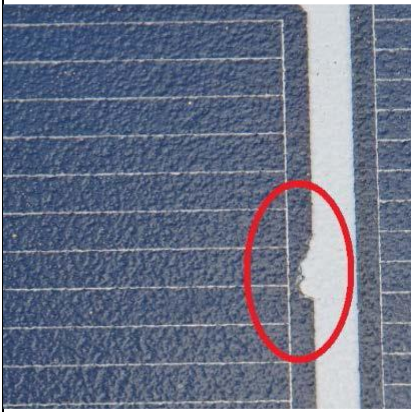
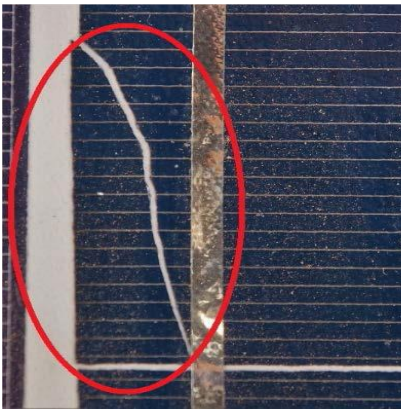
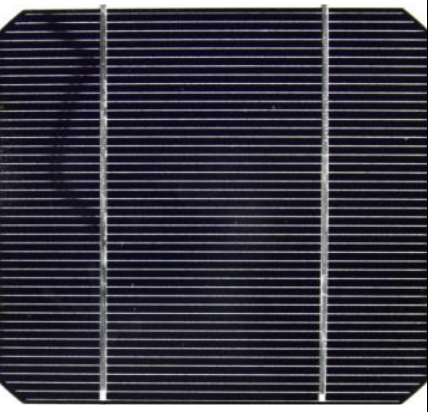
| EXAMPLES (page1) | | PVFS 1-1vs.01 | |
|---|---|--|---|
| Examples 1-3 | | | |

| EXAMPLES (page1) | | PVFS 1-1vs.01 | |
|---|---|--|---|
| | Cell chipping. A very small region is missing from the edge of the cell, but does not enter metalized region. [Köntges14] | Large crack at cell corner visible by eye - small portion of the cell (<10%) is no longer electrically connected. [Köntges14] | Cell crack with snail track. No isolation of any cell part. The propagation could isolate a cell area >10%. [Köntges14] |

| Component Defect | Module Cell cracks | PVFS 1-1vs.01 | | | |
|---|---|---|---|---|--|
| | Modules with a direct safety risk or a severity of 5 should be replaced. Regular inspections should be done to monitor the status of the not replaced modules. | | Adequate transport procedures, installation and cleaning by trained personal, in case of higher snow or hail risk use of therefore certified modules. | | Request EL pictures from production, pre-shipment or warehouse inspection, EL images with mobile laboratory before or during installation, regular EL inspection or after severe weather conditions. |

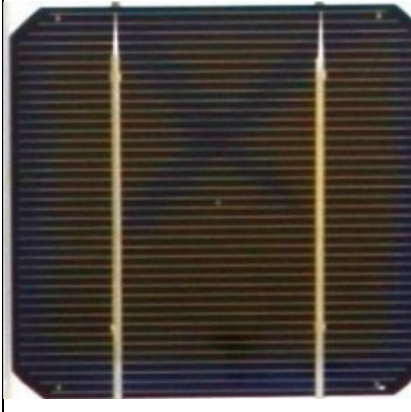
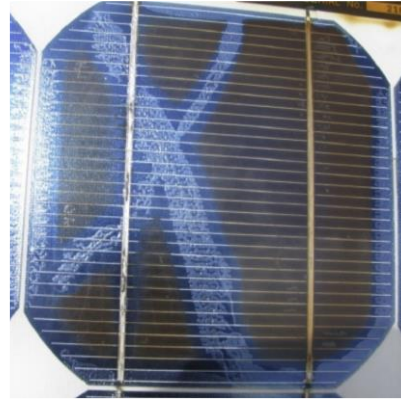
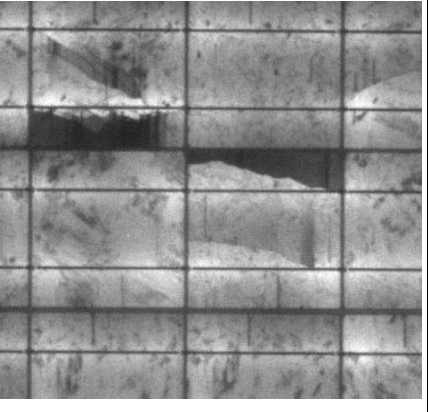
| EXAMPLES (page1) | | PVFS 1-1vs.01 | |
|---|---|--|---|
| Examples 4-6 | | | |

| EXAMPLES (page1) | | PVFS 1-1vs.01 | |
|---|---|--|---|
| | Cell cracks visible by the photo-bleaching effect. This may not be mistaken for snail tracks. [Köntges14] | Two cell cracks with extensive delamination, EVA browning and photo bleaching. [Yang19] | EL image of 2 cell cracks which isolates more than 10% of the cell area. [TUV Rheinland] |

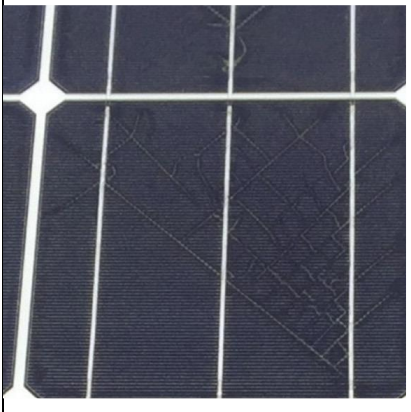
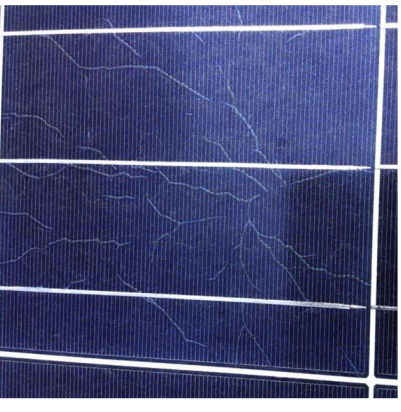
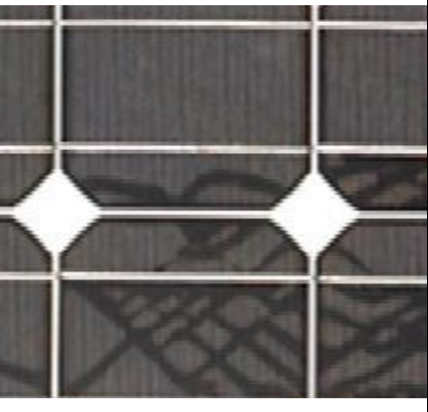
| EXAMPLES (page1) | | PVFS 1-1vs.01 | |
|---|---|--|---|
| Examples 7-9 | | | |

| EXAMPLES (page1) | | PVFS 1-1vs.01 | |
|---|---|--|---|
| | Snail track example. [Yang19] | Snail track example. [Yang19] | EL of cell cracks with snail tracks. [Köntges14] |

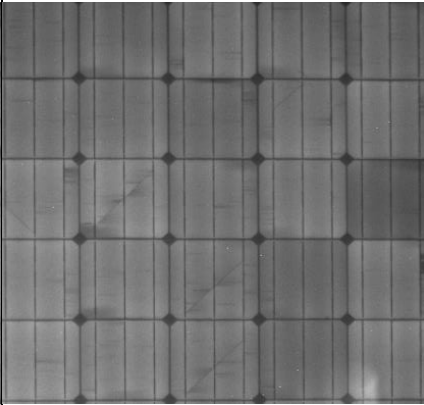
| EXAMPLES (page2) | | PVFS 1-1vs.01 | |
|---|--|--|---|
| Examples 13-15 | | | |

| EXAMPLES (page2) | | PVFS 1-1vs.01 | |
|---|--|--|---|
| | Cell crack with EVA delamination. [TUV Rheinland] (see also PVFS 1-3) | Typical EL picture of a cell crack caused by hail. [TUV Rheinland] | Repetitive crack pattern due to impact of soldering machine. [SUPSI] |

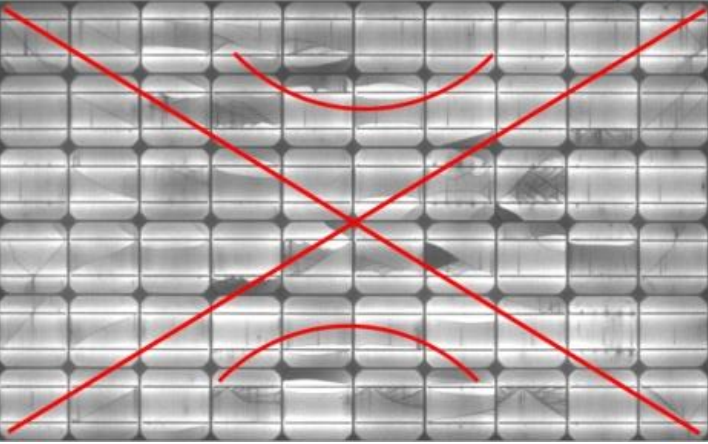
| EXAMPLES (page2) | | PVFS 1-1vs.01 | |
|---|--|--|---|
| Examples 16 | | | |

| EXAMPLES (page2) | | PVFS 1-1vs.01 | |
|---|--|--|---|
| | Typical EL picture of cell cracks caused by a heavy homogeneous mechanical load (X-crack pattern) also without glass breakage. [Köntges14] | | |

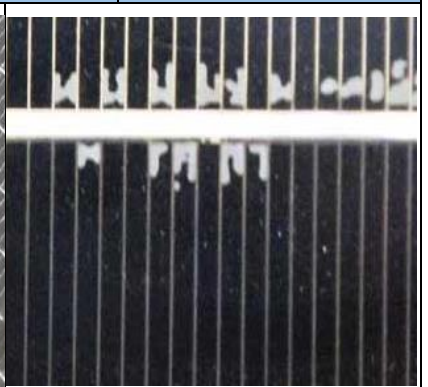
| <p>Examples 1-3</p> | | | | | | |

| | <p>Encapsulant delamination in un-critical position. [SUPSI]</p> | <p>Encapsulant delamination from cell caused by production process. [SUPSI]</p> | <p>Encapsulant delamination from cell along grid fingers and bus bar. [Packard12]</p> | | | |

| Component Defect | Module | PVFS 1-3vs.01 | |
|---|--|---|--|
| | Modules with a direct safety risk or a severity of 5 should be replaced. Regular inspections should be done to monitor the status of the not replaced modules. In case of individual module testing all modules which failed the insulation and/or wet-leakage test should be replaced. | Check validity of IEC 61215 certification and BOM, ground fault detection by inverter or other devices at all time. | Extended testing (e.g. damp heat), pre-shipment inspections (e.g. cross linking level of EVA) regular visual system inspections. |

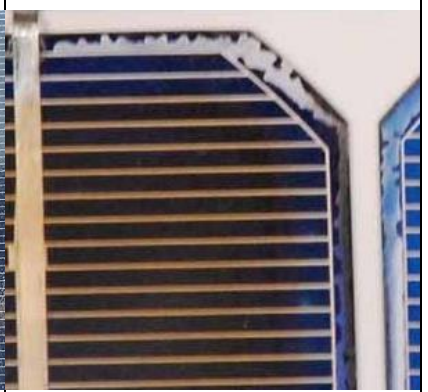
| <p>Examples 4-6</p> | | | | | | |

| | <p>Encapsulant delamination from glass (spotted due to glass texture) along the bus bars. [Packard12]</p> | <p>Encapsulant delamination along a cell crack. [Köntges16] (see also PVFS 1-1)</p> | <p>Encapsulant delamination near cell edges in combination with cell browning. [Packard12]</p> | | | |

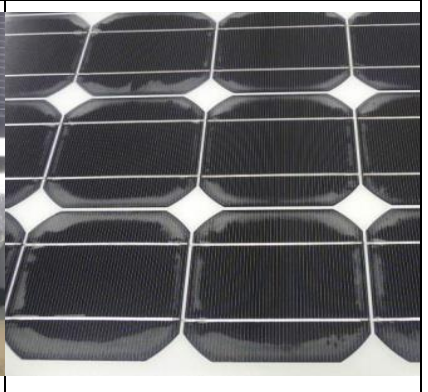
| <p>Examples 7-9</p> | | | | | | |

| | <p>Delamination in front of cell in the centre of the module. [Moser17] (see also FS 1-2)</p> | <p>Delamination at module insert connections of a glass/glass module (junction box). [SUPSI]</p> | <p>Delamination at cell edges. [Köntges14]</p> | | | |

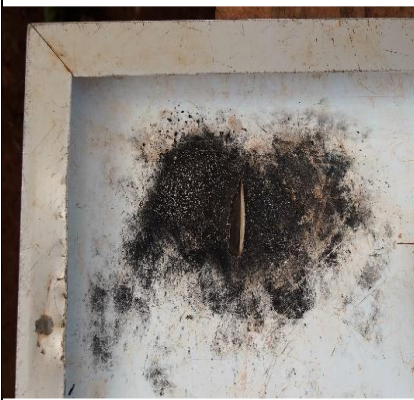
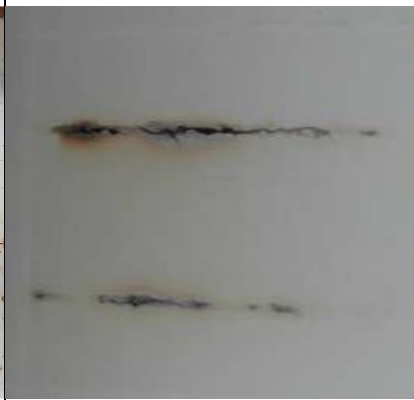
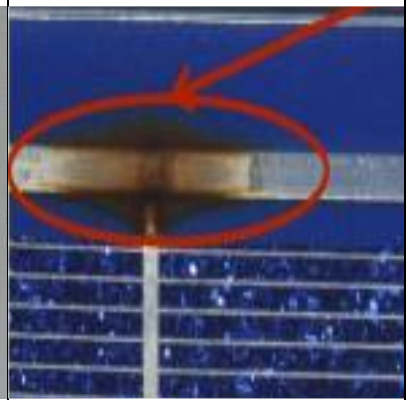
Examples
1-3

Burn mark at the backsheet with cracked backsheet. [Sinclair17]

Burn marks at the backsheet due to heating along a busbar. [Köntges14]

| Component Defect | Module Burn marks | PVFS 1-7vs.01 | |
|---|--|--|---|
| | Modules with a direct safety risk or a severity of 5 should be replaced. Regular inspections should be done to monitor the status of the not replaced modules. | Visual inspection before installation, commissioning of system with IRT. | Regular system inspections. |

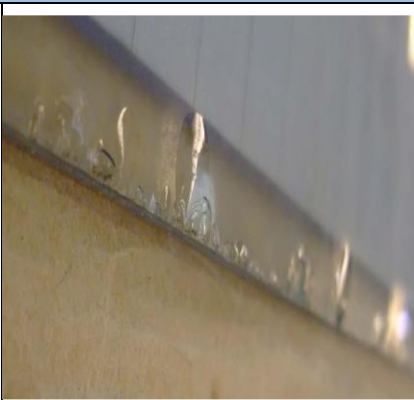
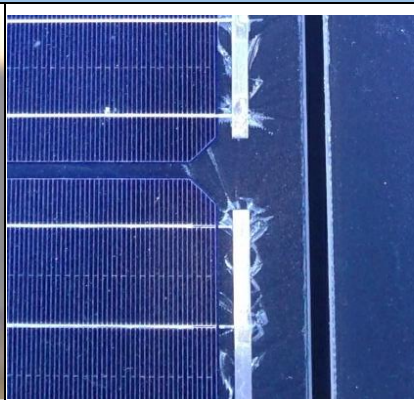
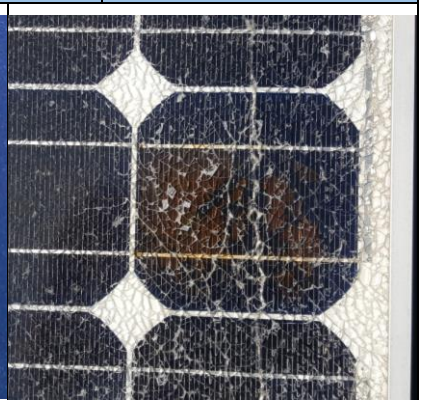
| <p>Examples 1-3</p> | | | |

| | <p>Chipped glass at the corner. [Packard12]</p> | <p>Glass breakage along the string interconnect ribbons due to weak manufacturing process. [SUPSI]</p> | <p>Glass breakage of tempered glass induced by a hot-spot. [SUPSI]</p> |

</p> | | | | | | |
| Mitigation | <table border="1" style="width: 100%; border-collapse: collapse;"> <thead> <tr> <th style="width: 33%;">Corrective actions</th> <th style="width: 33%;">Preventive actions (recommended)</th> <th style="width: 33%;">Preventive actions (optional)</th> </tr> </thead> <tbody> <tr> <td>All damaged modules have to be replaced.</td> <td>Adequate transport procedures, installation and cleaning by trained personal, in case of higher snow or hail loads use of certified modules.</td> <td>Regular system inspections.</td> </tr> </tbody> </table> | Corrective actions | Preventive actions (recommended) | Preventive actions (optional) | All damaged modules have to be replaced. | Adequate transport procedures, installation and cleaning by trained personal, in case of higher snow or hail loads use of certified modules. | Regular system inspections. |
| Corrective actions | Preventive actions (recommended) | Preventive actions (optional) | | | | | |
| All damaged modules have to be replaced. | Adequate transport procedures, installation and cleaning by trained personal, in case of higher snow or hail loads use of certified modules. | Regular system inspections. | | | | | |

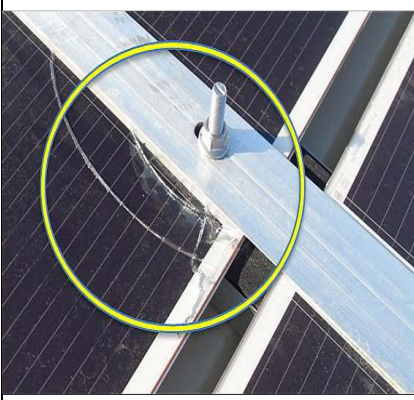
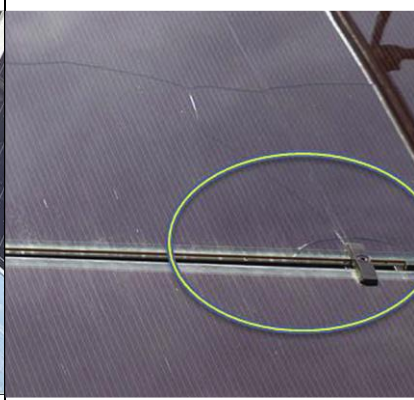
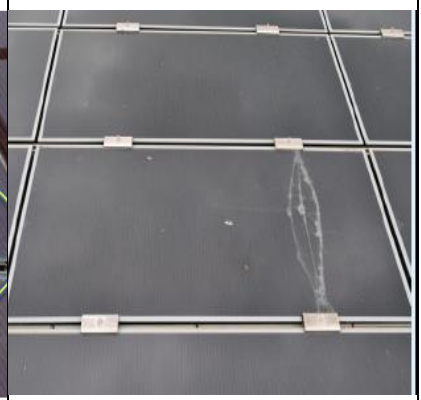
| <p>Examples 4-6</p> | | | |

| | <p>Glass breakage caused by too tight screws. [Köntges14] (see also PVFS 3-1)</p> | <p>Glass breakage caused due to poor clamp design. [Köntges14]</p> | <p>Glass breakage caused due to poor clamp design. [Köntges17] (see also PVFS 3-1)</p> |

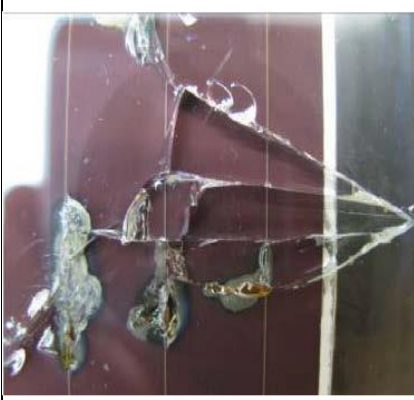
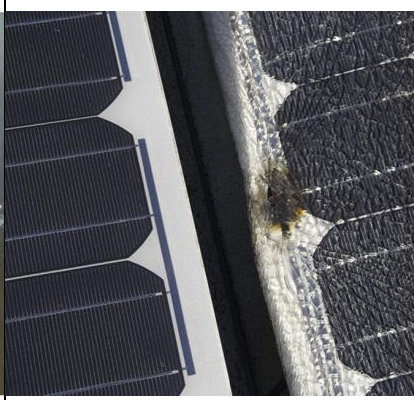
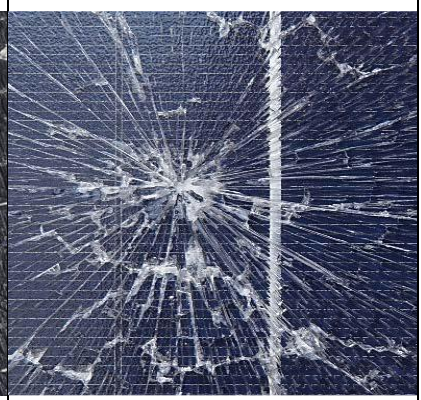
| <p>Examples 7-9</p> | | | |

| | <p>Glass breakage through high temperature gradient and not tempered glass. [Köntges14]</p> | <p>Glass breakage of tempered glass induced by burn mark. [Köntges17] (see also PVFS 1-7 and PVFS 1-9)</p> | <p>Breakage of tempered glass. [Köntges17]</p> |

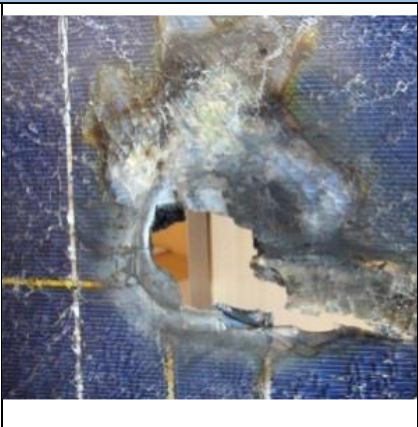
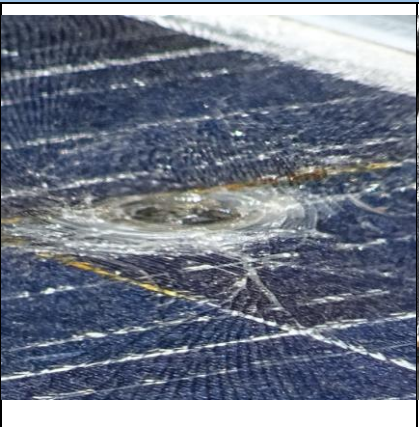
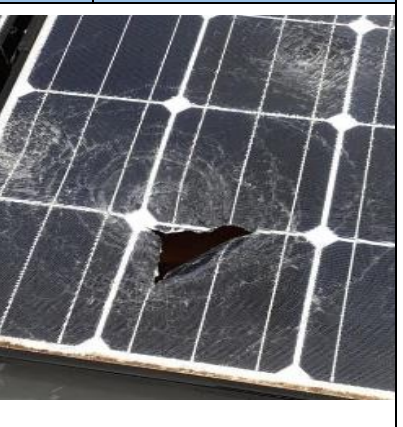
| <p>Examples 10-12</p> | | | | | | |

| | <p>Direct lightning stroke. [Köntges16]</p> | <p>Impact damage caused by a heavy object. [SUPSI]</p> | <p>Hail damage. [SUPSI]</p> | | | |

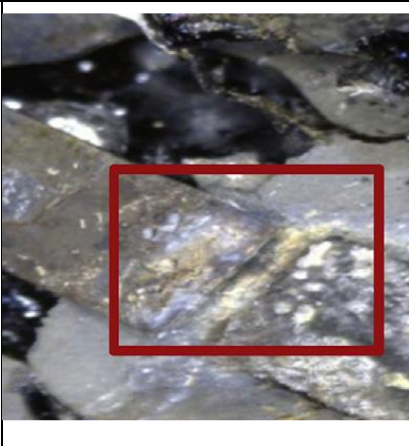
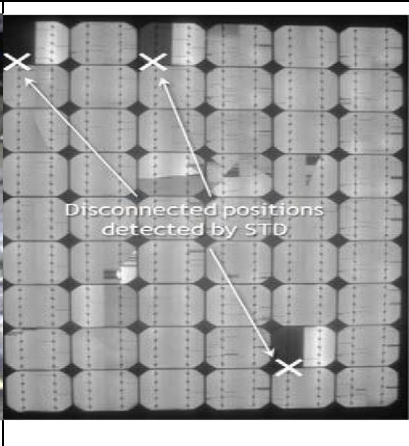
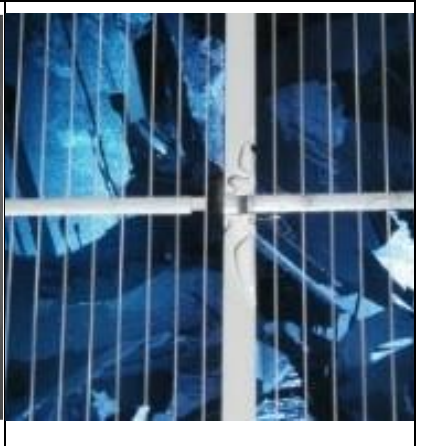
| <p>Examples 1-3</p> | | | | | | |

| | <p>Zoom of a broken cell interconnect. [Yang19]</p> | <p>EL image of a module with 3 cells with disconnected inter-connect ribbons. [Köntges14]</p> | <p>Disconnected cell interconnect with delamination. [Köntges17]</p> | | | |

| Component Defect | Module | PVFS 1-9vs.01 | |
|---|--|--|---|
| | Modules with a direct safety risk or a severity of 5 should be replaced. Regular inspections should be done to monitor the status of the not replaced modules. | Check validity of IEC 61215 certification and BOM. | Regular system inspections. |

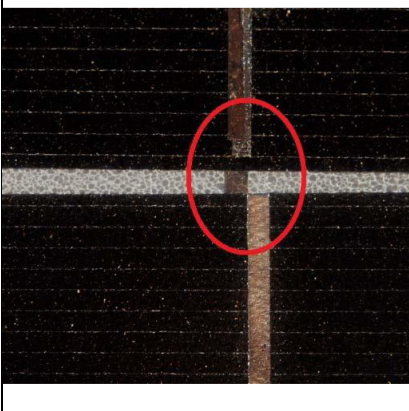
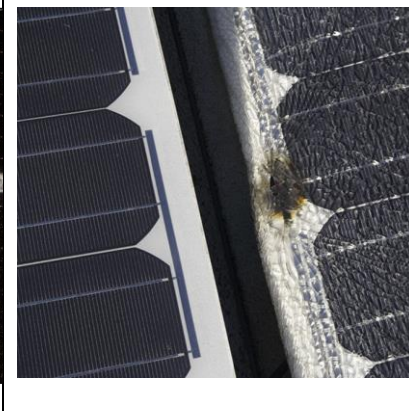
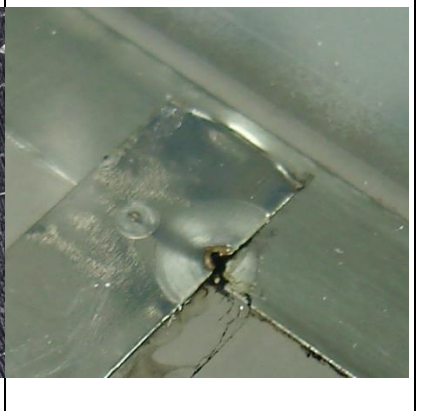
| <p>Examples 4-6</p> | | | | | | |

| | <p>Dislocation of interconnection ribbon. [Sinclair17]</p> | <p>Poor soldering of string inter-connect leading to burn mark and broken glass. [Yang19] (see also PVFS 1-7 and PVFS 1-8)</p> | <p>Micro arc which occur if the conductive glue on the string inter-connect has an insufficient contact. [Köntges14]</p> | | | |

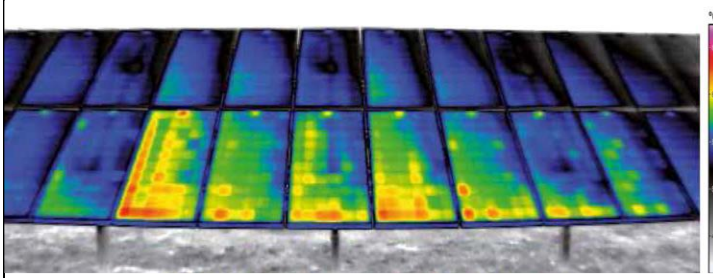
Examples
1-2

Strings with PID, detected with IR thermography. [Köntges14]

Dark IR thermography at I_{sc} for a module affected by PID. [Köntges14]

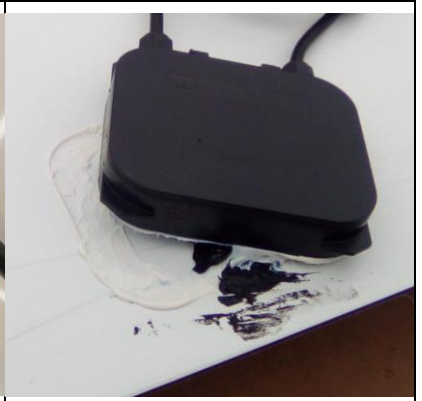
| <p>Examples 1-3</p> | | | | | | |

| | <p>Poorly bonded junction box on the backsheet. [Köntges14]</p> | <p>Open junction box in the field. [Yang19]</p> | <p>Detached junction box from backsheet. [SUPSI]</p> | | | |

| Component Defect | Module Defect or detached junction box | | PVFS 1-13vs.01 |
|---|--|--|---|
| | Modules with a direct safety risk or a severity of 5 should be replaced or repaired. Regular inspections should be done to monitor the status of the not replaced modules. | Check validity of IEC 61215 certification and BOM. Ground fault detection by inverter or other devices at all time. | Regular system inspections. |

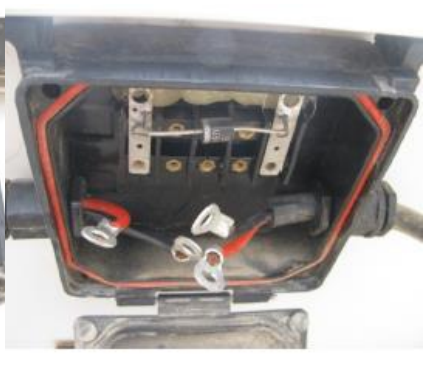
| <p>Examples 4-5</p> | | | | | | |

| | <p>Left: Missing junction box lid sealing with corrosion of contacts. Right: Good junction box sealing. [India13]</p> | | <p>Missing seal or strain relive of module cables, improper cable inlet. [Sinclair17]</p> | | | |

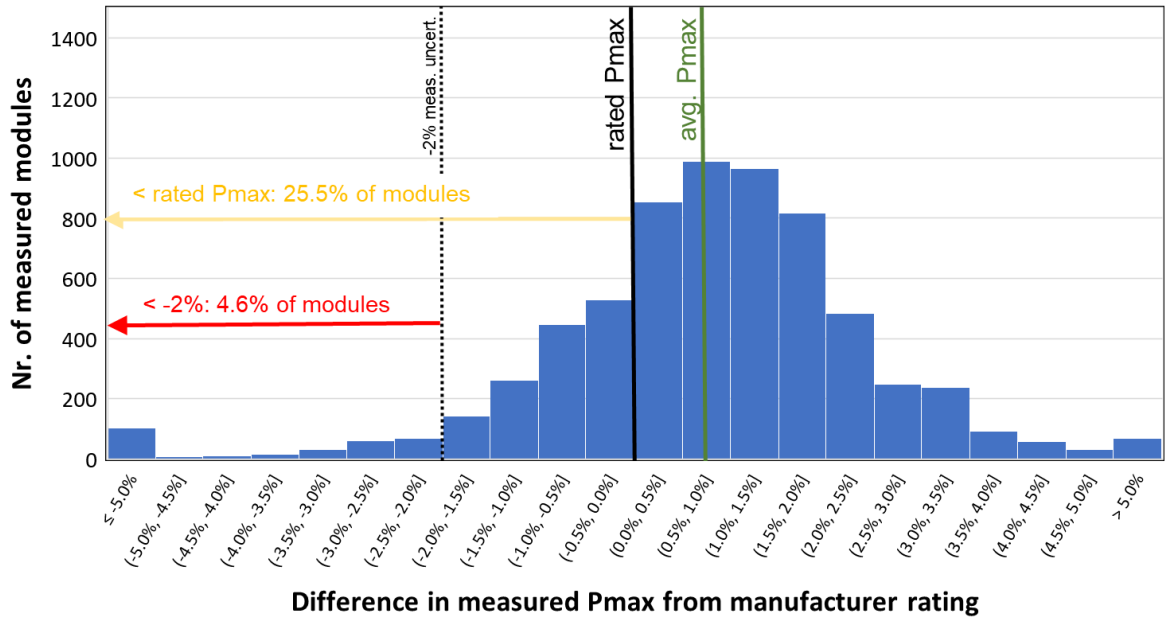
Examples
2

Statistical analysis done by Eternalsun on around 6500 new modules with 96 different PV module types from 29 different manufacturers. [Herrmann21] Considering the measurement uncertainty of +/-2% a total of 4.6% of the modules are below the gate 1 limit defined by the IEC 61215 standard. [IEC 61215-1:2021]

Note: In case of a measurement uncertainty of +/-5% none of the PV modules would fail, but it would be not conform to the IEC 61215 standard prescribing a maximum measurement uncertainty for c-Si modules of +/-3%.

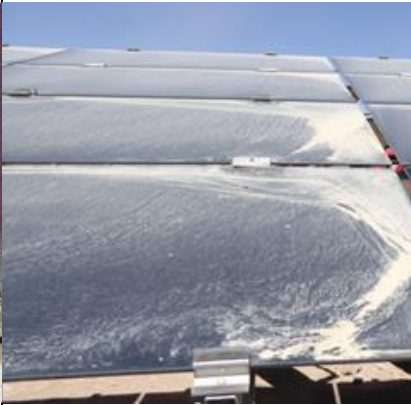
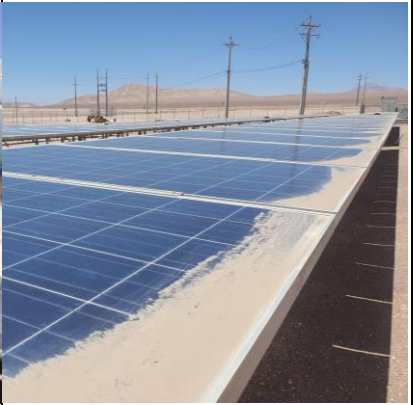
| <p>Examples 4-6</p> | | | |

| | <p>Moss growing on the edge of a module combined with edge soiling. [Köntges17]</p> | <p>Soiling pattern on a system in the Atacama desert. [ISE]</p> | <p>Soiling pattern demonstrating dominant wind direction on a test site in Atacama desert. [ISE]</p> |

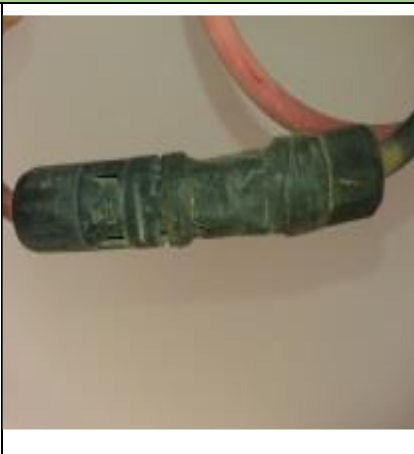
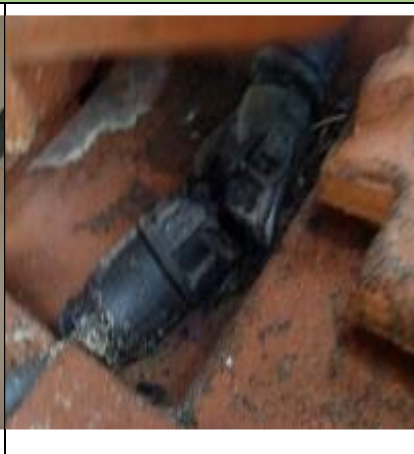
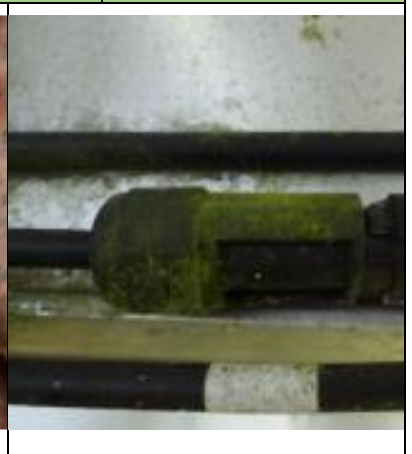
| <p>Examples 1-3</p> | | | | | | |

| | <p>Weathered connector. [Köntges17]</p> | <p>Cracked connector. [Köntges17]</p> | <p>Corroded connector. [Köntges17]</p> | | | |

| Component | Cables and Interconnectors | | PVFS 2-2vs.01 |
|---|--|---|--|
| | Components constituting a direct safety risk should be replaced. Regular inspections should be done to monitor the status of the not replaced components. | Protection of connectors and cables from humidity during installation. Use of adequate crimping tools. Installation should be done by trained personal. | Signature of a contractual agreement for maintenance of the warranty when connectors are substituted by the installer, perform regular system inspections. |

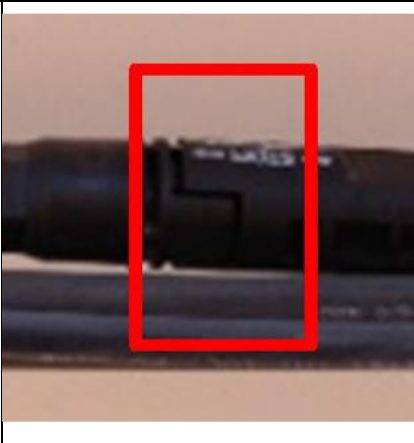
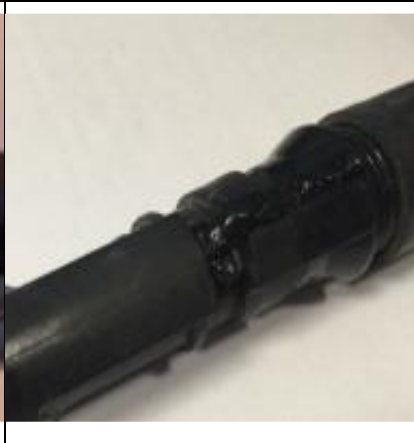
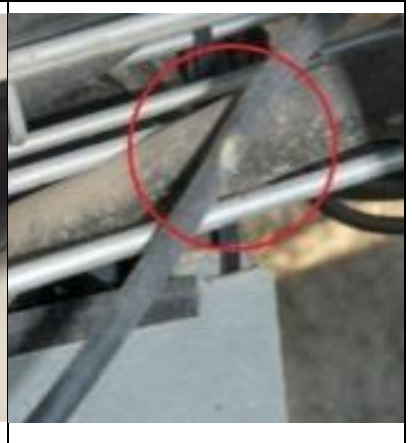
| <p>Examples 4-6</p> | | | | | | |

| | <p>Not fully inserted or interlocked connector. [Yang19]</p> | <p>Melted connector. [Köntges17]</p> | <p>Cracked/disintegrated cable insulation. [Köntges17]</p> | | | |

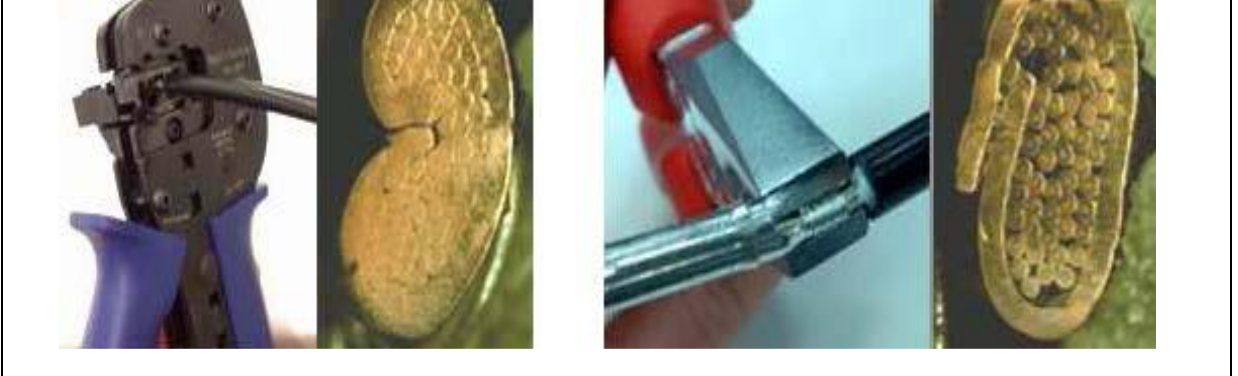
| <p>Examples 7</p> | | | | | | |

| | <p>Incorrect crimping (right) versus correct crimping (left). [PVSurvey19]</p> | | | | | |

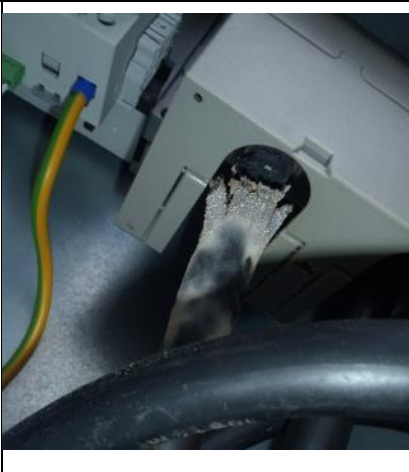
| <p>Examples 4</p> | | | |

| <p>Connecting terminals show signs of burning, have melted or charred. [TUV Rheinland]</p> | | | |

| Component Defect | Cables and Interconnectors | | FS 2-4vs.01 |
|---|---|--|---|
| | Replace the components with defect or abnormal temperature. | Use IRT to check the components and connection to find poor connection or defect components. | |

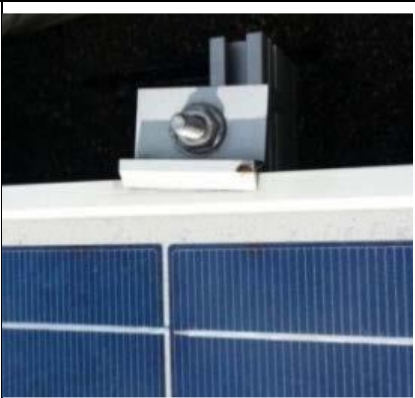
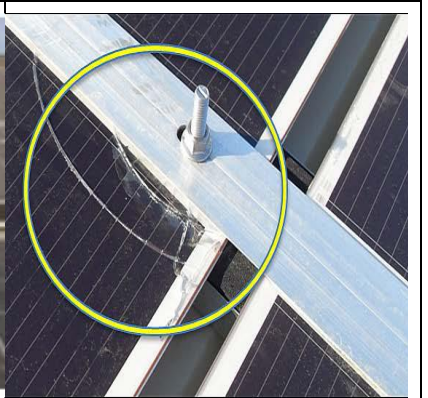
| <p>Examples 1-3</p> | | | |

| | <p>Improper installation of clamp.</p> | <p>Wrong combination of clamps and modules. [Moser17]</p> | <p>Glass breakage caused by too tight screws. [Herrmann21] (see also PVFS 1-8)</p> |

| | Modules with a safety risk or a severity of 5 should be replaced. | Use only compatible clamps (mounting structure/ modules/ clamps) and follow manufacturer mounting instructions. Check local wind and snow loads. | Testing of non-standard mounting configurations by an accredited test laboratory (eg. facade mounting), perform regular system inspections |

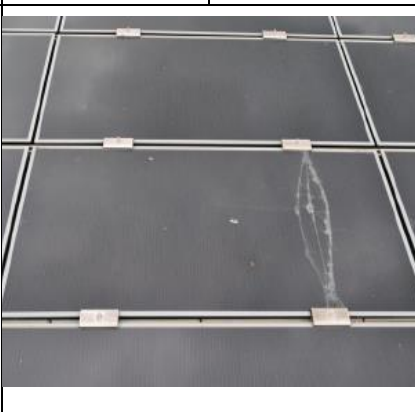
| <p>Examples 4</p> | | | |

| | <p>Glass breakage caused by poor clamp design. [Moser17] (see also PVFS 1-8)</p> | | |

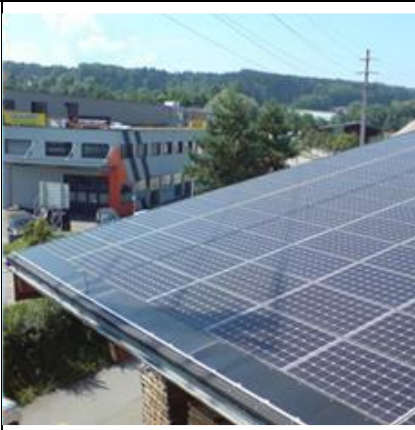
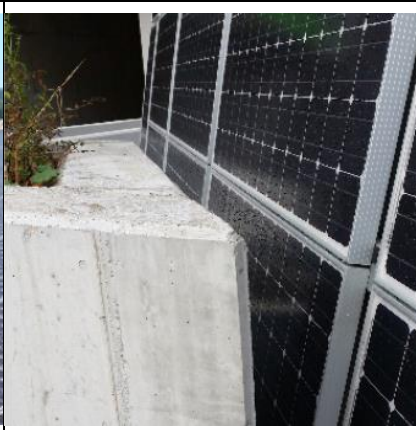
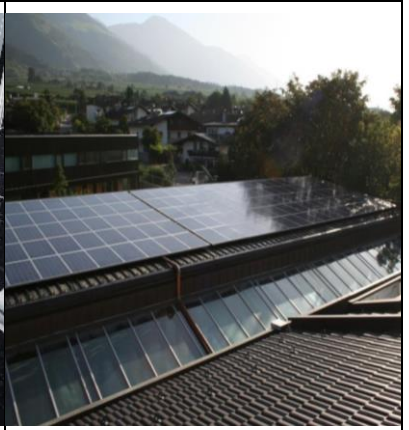
| <p>Examples 1-3</p> | | | | | | |

| | <p>Shading by pole-and-wire (poor design: too close to nearby shading objects). [Jahn18]</p> | <p>Shading due to bad planning or coverage by afterwards build construction element. [Moser17]</p> | <p>Shading by tree with seasonal changes due to foliage. [Moser17]</p> | | | |

| Component Defect | Mounting Module shading | | PVFS 3-3vs.01 |
|---|---|--|---|
| | Indirectly damaged modules with a safety or severity risk of 5 should be replaced or repaired. Eventual trees or vegetation responsible for the increased shading loss should be cut. | A basic shading analysis (full year solar/shade data) is recommended to identify areas and periods of major shading. Areas exposed to shading within the central part of the day or sunny season should be avoided or appropriate/cost-effective shading mitigation measure should be implemented. | A detailed shading loss analysis should be done which estimates and compares different system configurations and shading mitigation measures. Perform regular system inspections. |
