Component	Module		PVFS 1-6vs.01
Defect	Backsheet chalking (whitening)		
Appearance	White powder is detectable on the external surface of the backsheet. It can be seen by passing a finger over the backsheet. It can be removed. The backsheet has usually a rough or dull appearance.		
Detection	VI		
Origin	Chalking is caused by the photothermal degradation of the polymers in the outer backsheet layer containing inorganic pigments. For example, TiO <sub>2</sub> pigments are often used in the outer layers as UV blocker.		
	Production <input checked="" type="checkbox"/>	Installation <input type="checkbox"/>	Operation <input checked="" type="checkbox"/>
Impact	Chalking does not affect module safety or performance on first sight, but it can be a sign for an ongoing degradation of the backsheet and a precursor for severe backsheet cracking. Due to the degradation-induced reduction of UV protection, more serious failures, such as <b>backsheet cracking</b> and <b>insulation failures can occur</b> . Enhanced moisture diffusion into the encapsulant/active PV-parts can lead to <b>corrosion</b> of cells and connectors, having a negative impact also on the performance.

Component Defect	Module	PVFS

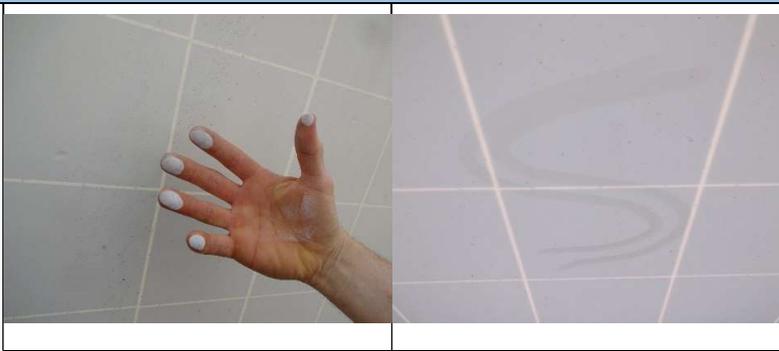
<p>Examples 1-2</p>

<p>Finger with white powder. [TUV Rheinland]</p>	<p>Fingerprint on a module with chalking. [TUV Rheinland]</p>				
<p>Severity</p>

Mitigation	Corrective actions	Preventive actions (recommended)	Preventive actions (optional)
	Regular inspections should be done to monitor the progress of the observed failure. Ground fault detection by inverter or other devices at all time.	Check validity of IEC 61215 certification and BOM.	Regular system inspections.

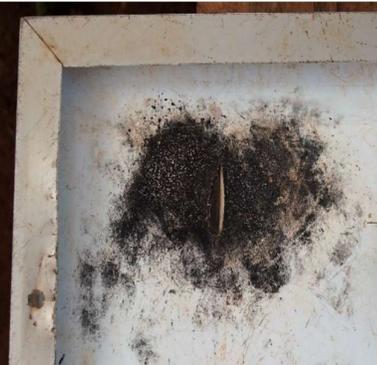
<p>Burn mark at the backsheet with cracked backsheet. [Sinclair17]</p>	<p>Burn marks at the backsheet due to heating along a busbar. [Köntges14]</p>	<p>Burn mark associated with overheating along the metallic interconnection (without back-sheet damage). [Köntges14]</p>
<p>Severity</p>

Performance:
Mitigation	Corrective actions	Preventive actions (recommended)	Preventive actions (optional)
	<b>Modules with a direct safety risk or a severity of 5 should be replaced.</b> Regular inspections should be done to monitor the status of the not replaced modules.	Visual inspection before installation, commissioning of system with IRT.	Regular system inspections.

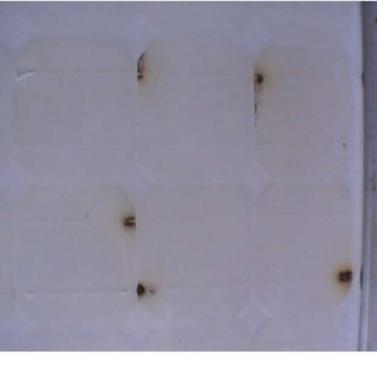
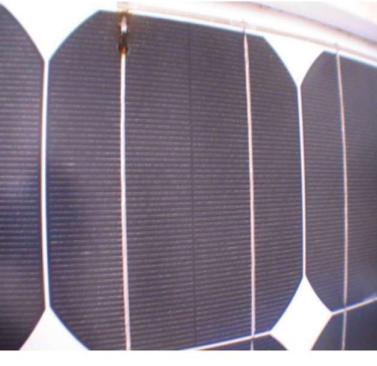
<p>Front and back side view of burn marks caused by open-circuited bypass diodes and current mismatch conditions (due to shading or cracked cells). [Köntges14]</p>		<p>Burn marks caused by defect bypass diodes or an interconnect failure in the junction box. [Köntges14]</p>
<p>Severity</p>

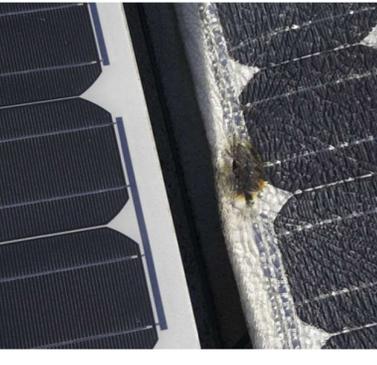
<p>Burn mark with broken glass caused by poor bussing ribbon soldering. [Yang19] (s. also PVFS 1-8 and PVFS 1-8)</p>	<p>Burn mark due to intrinsic shunting caused by error in manufacturing process. [Yang19]</p>	<p>Burn mark due to intrinsic shunting caused by error in manufacturing process. [Yang19]</p>

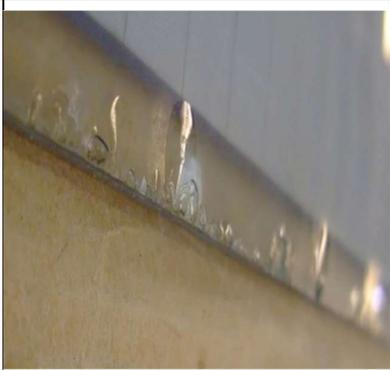
<p>Chipped glass at the corner. [Packard12]</p>	<p>Glass breakage along the string interconnect ribbons due to weak manufacturing process. [SUPSI]</p>	<p>Glass breakage of tempered glass induced by a hot-spot. [SUPSI]</p>
<p>Severity</p>

Mitigation	Corrective actions	Preventive actions (recommended)	Preventive actions (optional)
	<b>All damaged modules have to be replaced.</b>	Adequate transport procedures, installation and cleaning by trained personal, in case of higher snow or hail loads use of certified modules.	Regular system inspections.

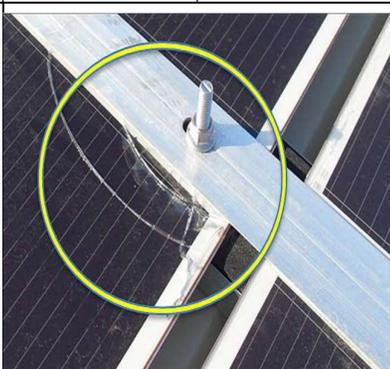
<p>Glass breakage caused by too tight screws. [Köntges14] (see also PVFS 3-1)</p>	<p>Glass breakage caused due to poor clamp design. [Köntges14]</p>	<p>Glass breakage caused due to poor clamp design. [Köntges17] (see also PVFS 3-1)</p>
<p>Severity</p>

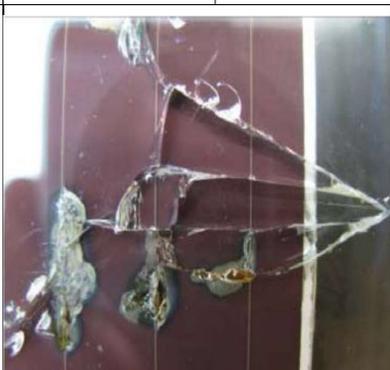
<p>Glass breakage through high temperature gradient and not tempered glass. [Köntges14]</p>	<p>Glass breakage of tempered glass induced by burn mark. [Köntges17] (see also PVFS 1-7 and PVFS 1-9)</p>	<p>Breakage of tempered glass. [Köntges17]</p>
<p>Severity</p>

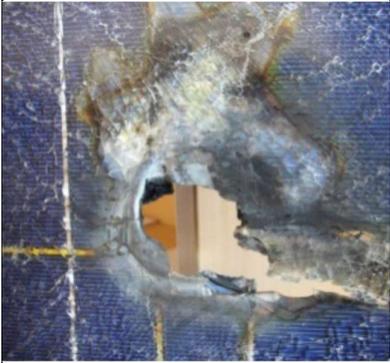
<p>Direct lightning stroke. [Köntges16]</p>	<p>Impact damage caused by a heavy object. [SUPSI]</p>	<p>Hail damage. [SUPSI]</p>
<p>Severity</p>

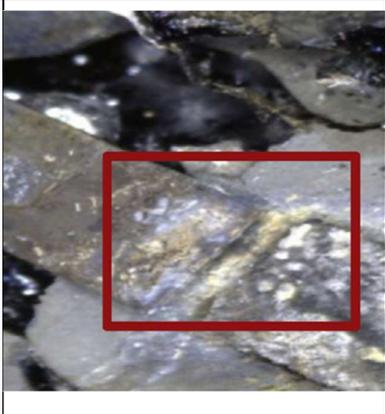
<p>Zoom of a broken cell interconnect. [Yang19]</p>	<p>EL image of a module with 3 cells with disconnected inter-connect ribbons. [Köntges14]</p>	<p>Disconnected cell interconnect with delamination. [Köntges17]</p>			
<p>Severity</p>

Performance:
Mitigation	Corrective actions	Preventive actions (recommended)	Preventive actions (optional)
	<b>Modules with a direct safety risk or a severity of 5 should be replaced.</b> Regular inspections should be done to monitor the status of the not replaced modules.	Check validity of IEC 61215 certification and BOM.	Regular system inspections.

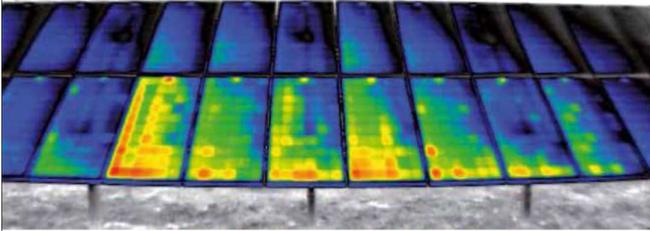
<p>Strings with PID, detected with IR thermography. [Köntges14]</p>	<p>Dark IR thermography at <math>I_{sc}</math> for a module affected by PID. [Köntges14]</p>
<p>Severity</p>

Component Defect	Module Potential induced degradation (PID) (page2)		PVFS 1-10vs.01
Mitigation	<p>Corrective actions</p> <p>How to proceed depends very much on the stage on which PID is detected. If detected in an early stage recovery is possible by applying a reverse voltage during night-time. Specific anti PID kits are available on the market promising a recovery of the lost power. As there is not a full guarantee that the recovery will be effective for the specific situation, it should be monitored or measured to see if the problem has been sufficiently solved. In the case of progressed PID without visible module damages, the recovery could need several months or even years suggesting in any case a replacement of all modules with modules tested to be PID resistant.</p>	<p>Preventive actions (recommended)</p> <p>Modules tested for PID accord. IEC 62804-1 should be less prone to PID (verify that BOM corresponds!)</p>	<p>Preventive actions (optional)</p> <p>PID prevention at system level: The installation of an inverter with transformer can be considered as mitigation measure for the PID phenomenon. On the other hand, the trade-off with the inverter efficiency and the cost of the inverter must be taken into account. Anti-PID insurance.</p>

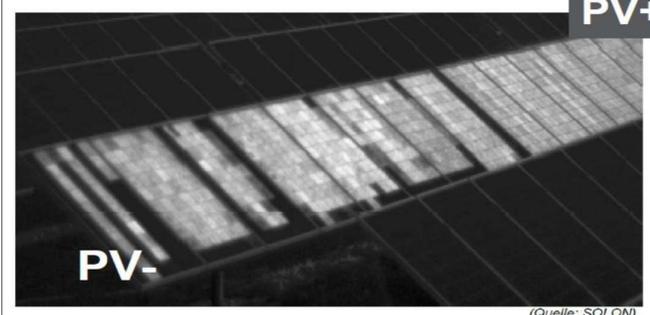
<p>Strings with PID, detected with EL imaging.</p>	<p>Electroluminescence image made at <math>I_{sc}</math> for a module affected by PID. [Köntges14]</p>
<p>Severity</p>

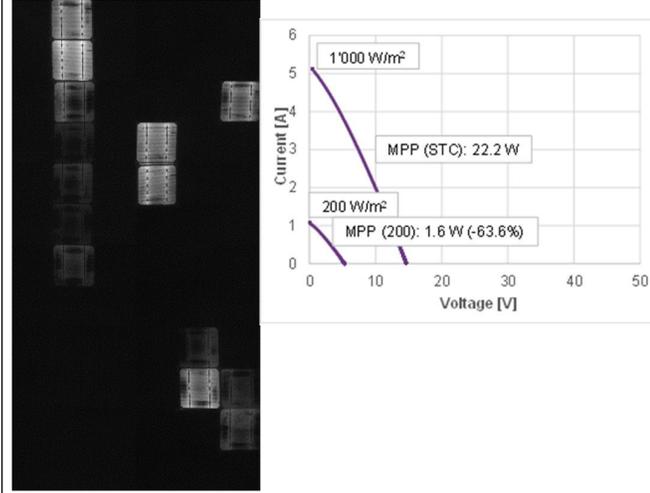
<p>PID affected module with power loss of 89%, left: EL at <math>1.5 \times I_{sc}</math>, right: I-V curve of the same module at 1000 and 200 W/m<sup>2</sup>. [Herrmann21]</p>	<p>PID affected module with power loss of 14%. top: EL at <math>1.5 \times I_{sc}</math>. bottom: EL of the same module at <math>0.2 \times I_{sc}</math>. [Herrmann21]</p>
