Component Defect	Module <b>Metallisation discolouration/corrosion</b>		<b>PVFS 1-11vs.01</b>
Appearance	<p>The discolouration and/or corrosion of the cell metallisation and the interconnections is getting visible as a light yellow to dark brown to black discolouration of the electrical parts. Depending on the material combinations corrosion is furthermore noticeable by the presence of galvanic products that may appear powdery, white, light gray, and/or have a yellow, blue, or green tinge. The defect occurs typically at the solder bonds, on the cell gridlines/fingers or the cell/string interconnect ribbons. It is very often observed together with other failures like <b>delamination</b> and <b>discolouration</b> of the encapsulant and sometimes with <b>burn marks</b>. Under certain circumstances corrosion is more visible near cell edges. Dark areas at the cell borders of the EL images can here highlight the diffusion of moisture through the rear side of the module and the gaps between the cells and the subsequent front side cell corrosion starting from the edges.</p>

Component Defect	Module Glass corrosion or abrasion	PVFS 1-12vs.01			
Appearance	The degradation of the glass front l

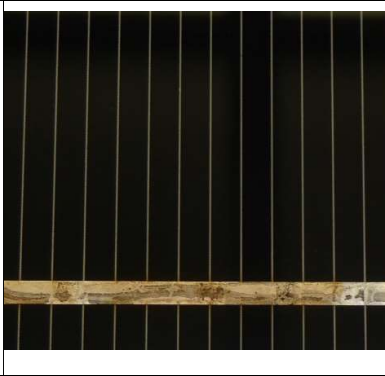
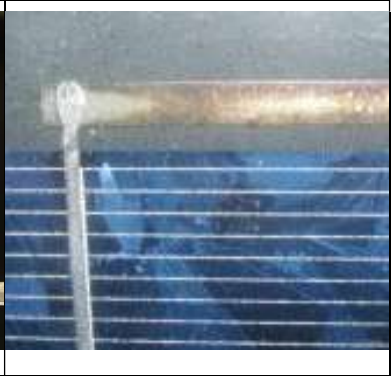
<p>Examples 1-3</p>

Detection	VI, (EL, IV)		
Origin	<p>The corrosion/oxidation of the metallisation is caused by the presence of moisture and acidity in the encapsulant, as e.g. acetic acid, a degradation product of the mostly used encapsulant EVA or remaining crosslinker (peroxides). Acetic acid has a corrosive effect on the cell metallisation and the cell interconnect. The ingress of moisture caused by an ongoing delamination process leads together with the oxygen to a further acceleration of the corrosion. Corrosion can be caused by a poor manufacturing process (e.g residual crosslinker due to a too short lamination process; imperfections in cell soldering) or the choice of poor materials (low corrosion resistance of tin-based coating of copper ribbons, high water permeability of back sheet and/or encapsulant materials). Environmental factors can accelerate the corrosion (e.g ammonia, salt, humidity, temperature). For these reasons, corrosion is more frequent and severe under hot and humid climates or in agriculture or maritime environments. Discolouration can be also related to non-corrosive processes like a discolouration due to light-sensitive solder flux residues on the ribbon.</p>

<p>Discolouration due to corrosion or to light-sensitive flux residues on the ribbon.</p>	<p>Discolouration due to corrosion on the ribbon. [SUPSI]</p>	<p>String interconnect corrosion. [Köntges17]</p>			
<p>Severity</p>

Mitigation	Corrective action	Preventive actions (recommended)	Preventive actions (optional)
	<b>Modules with a direct safety risk or a severity of 5 should be replaced.</b> Regular inspections should be done to monitor the status of the not replaced modules.	Check validity of IEC 61215 certification and BOM.	Regular system inspections.

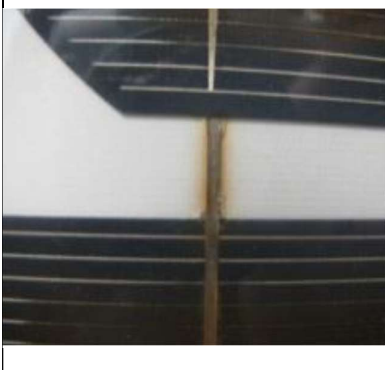
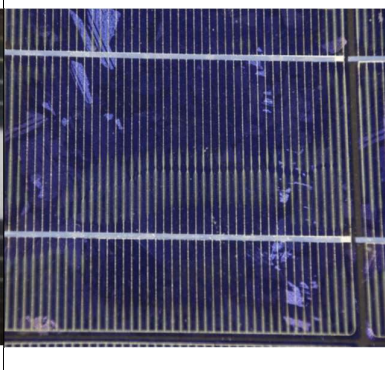
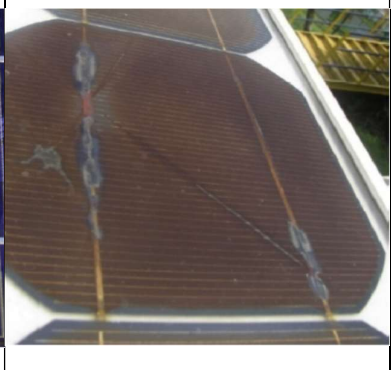
<p>Examples 4-6</p>

<p>Cell interconnect corrosion. [Köntges17]</p>	<p>Modules with light Ag finger oxidation after 5 years in the field. [Yang19]</p>	<p>Severe oxidation/corrosion and burn marks on the Ag fingers, busbars, and interconnects of modules after 25 years. [Yang19]</p>			
<p>Severity</p>

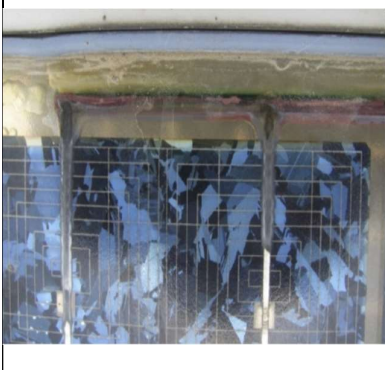
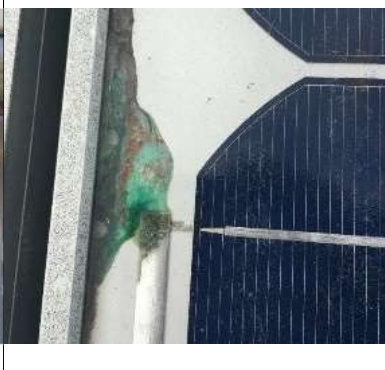
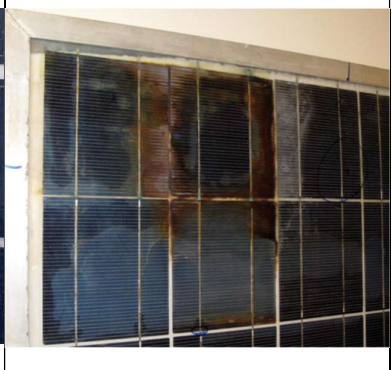
<p>Examples 7-9</p>

<p>Corrosion seen as red, green and black discoloration in the string interconnect. [Yang19]</p>	<p>Busbar corrosion and delamination at the edge. [SUPSI]</p>	<p>Glass/glass module showing delamination and subsequent corrosion. [Köntges17]</p>

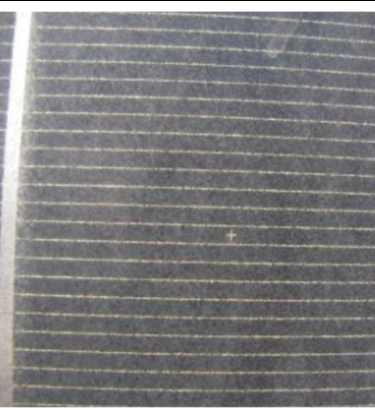
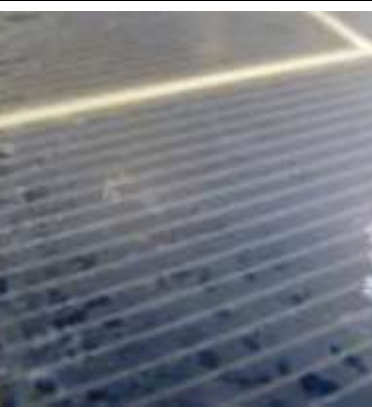
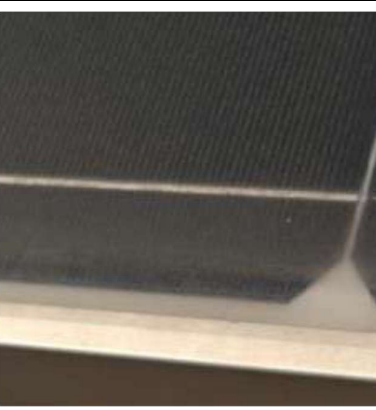
<p>Examples 1-3</p>

<p>Zoom of module with hazy glass (homogenous discoloration) due to surface corrosion. [India13]</p>	<p>Zoom of module with hazy glass (heterogenous discoloration) due to surface corrosion. [Petter11]</p>	<p>Hazy glass due to glass corrosion close to frame. [India18]</p>			
<p>Severity</p>

Mitigation	Corrective actions	Preventive actions (recommended)	Preventive actions (optional)		
	<b>Modules with a direct safety risk or a severity of 5 should be replaced.</b> Depends on the level of performance loss. For extreme environments (e.g. near to mines, cement factories), evaluate cost-effectiveness of replacing modules with lost yield.	Check validity of IEC 61215 certification and BOM, appropriate component selection in function of intended application.	Regular system inspections.

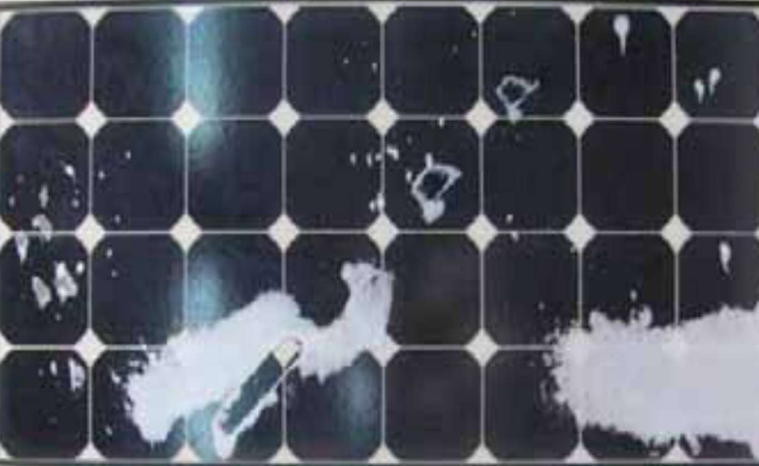
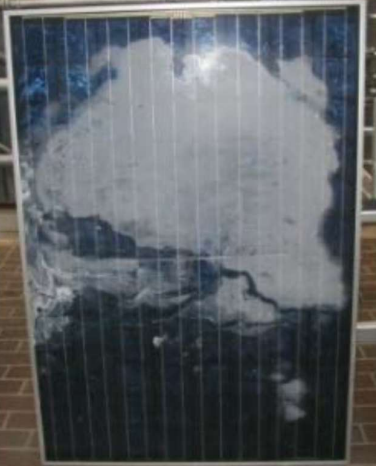
<p>Examples 4-5</p>

<p>Glass corrosion on the front of a mono-Si back-contact module after damp heat 90/90 testing. [Walsh20]</p>		<p>Glass corrosion. [Köntges16]</p>			
<p>Severity</p>

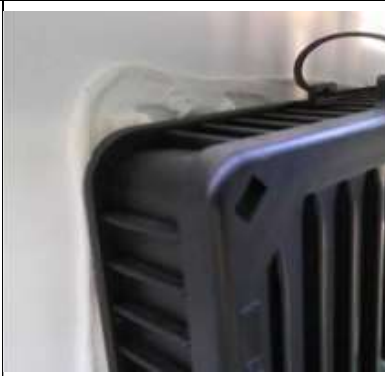
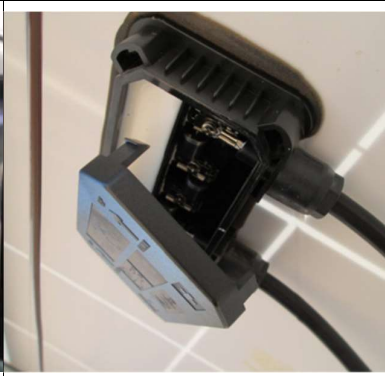
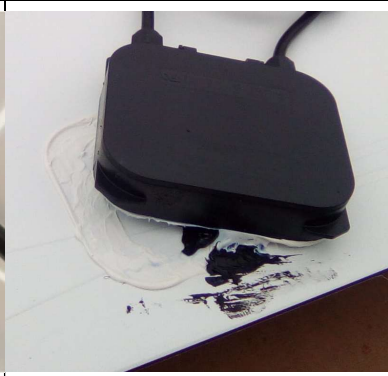
<p>Examples 1-3</p>

<p>Poorly bonded junction box on the backsheet. [Köntges14]</p>	<p>Open junction box in the field. [Yang19]</p>	<p>Detached junction box from backsheet. [SUPSI]</p>			
<p>Severity</p>

Mitigation	Corrective actions	Preventive actions (recommended)	Preventive actions (optional)
	<b>Modules with a direct safety risk or a severity of 5 should be replaced or repaired.</b> Regular inspections should be done to monitor the status of the not replaced modules.	Check validity of IEC 61215 certification and BOM. Ground fault detection by inverter or other devices at all time.	Regular system inspections.

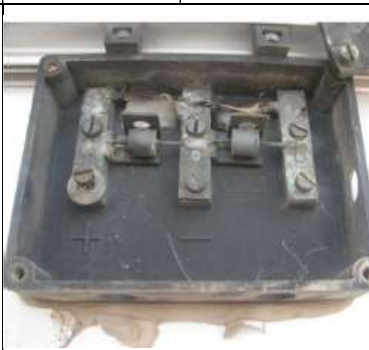
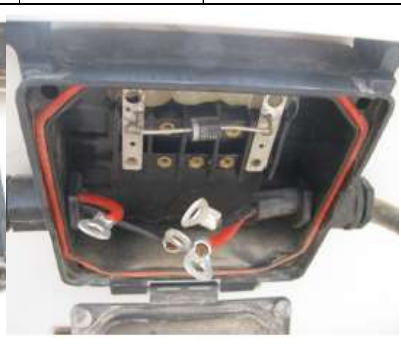
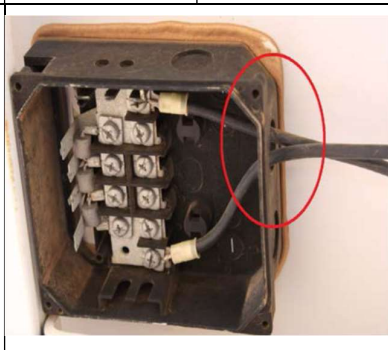
<p>Examples 4-5</p>

<p>Left: Missing junction box lid sealing with corrosion of contacts. Right: Good junction box sealing. [India13]</p>		<p>Missing seal or strain relive of module cables, improper cable inlet. [Sinclair17]</p>			
<p>Severity</p>

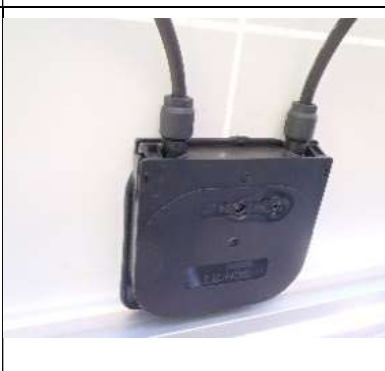
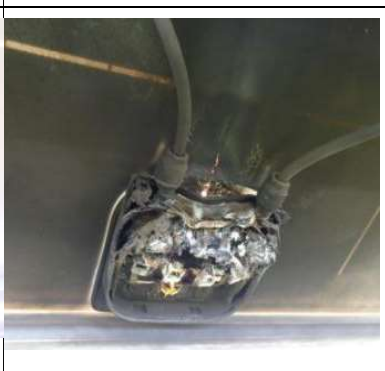
<p>Examples 6-7</p>

<p>Melted junction box. [TUV Rheinland]</p>	<p>Burned junction box caused by corroded contacts within the junction box. [TUV Rheinland]</p>				
<p>Severity</p>

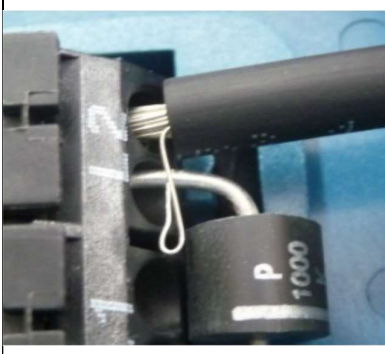
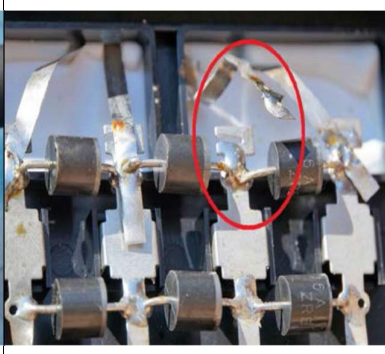
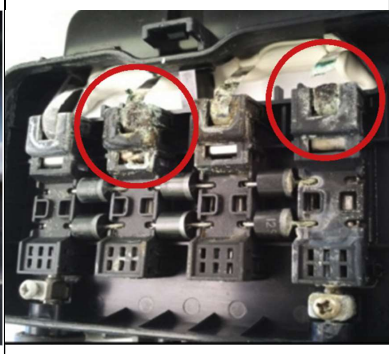
<p>Examples 1-3</p>

<p>Junction box with poor wiring. [Köntges14]</p>	<p>Detached tabbing ribbon due to bad soldering. [Köntges14]</p>	<p>Corrosion failure due to water soaking of the IP65 rated Jbox. [Yang19]</p>
<p>Severity</p>

Mitigation	Corrective actions	Preventive actions (recommended)	Preventive actions (optional)
	<b>Modules with a direct safety risk or a severity of 5 should be replaced.</b> Regular inspections should be done to monitor the status of the not replaced modules.	Check validity of IEC 61215 certification and BOM. Ground fault detection by inverter or other devices at all time.	Testing of modules with mobile test centre before installation, regular system inspection, installation of arc detection tool.

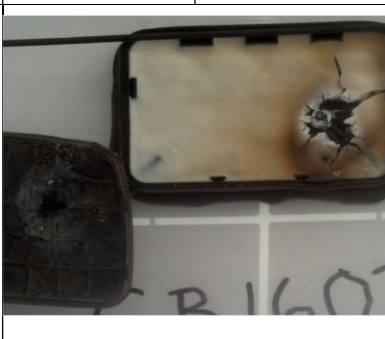
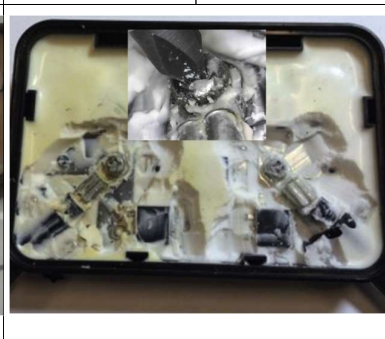
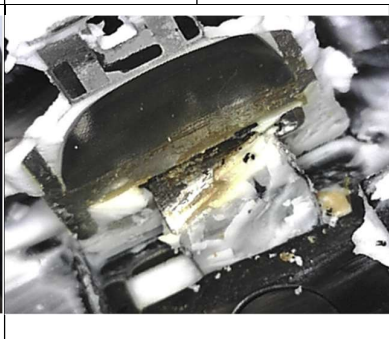
<p>Examples 4-6</p>

<p>Jbox failure due to poor electric connection. [Yang19]</p>	<p>Evidence of loose screw connection inside Jbox with browning of pottant. [Yang19]</p>	<p>Cold soldering of module busing ribbon to the Jbox connection terminal pad with minor browning of pottant. [Yang19]</p>	
<p>Severity</p>

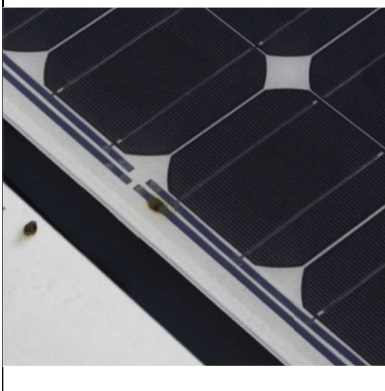
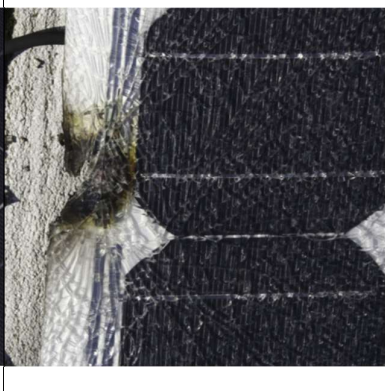
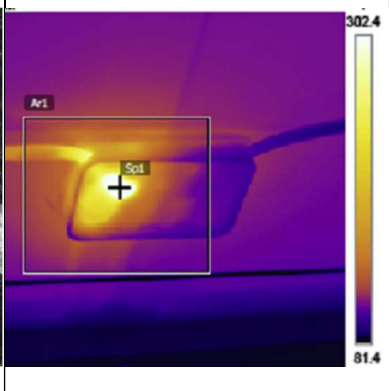
<p>Examples 7-9</p>

<p>Overheating due to the poor Jbox interconnect leading to light discoloration and burn mark on front and back side. [Yang19]</p>	<p>Overheating due to the poor Jbox interconnect leading to burn mark and glass breakage. [Yang19]</p>	<p>IR imaging of a hotspot Jbox due to loose electric connection inside. [Yang19]</p>
