# PARTIAL SHADING INDUCED DEGRADATION

## 2018-2020 FIELD STUDY

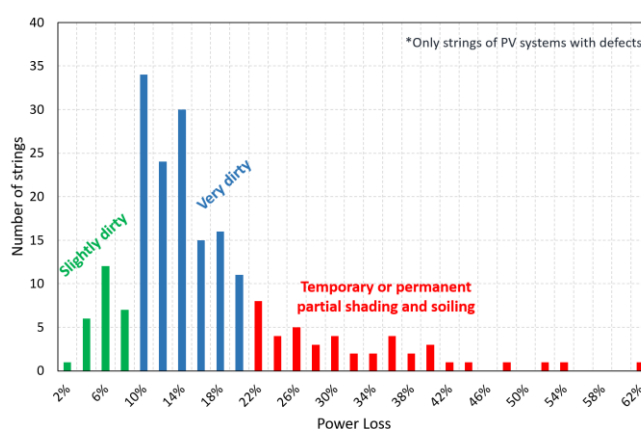
Figure 1: Percentage of strings with detected defects among 203 strings from 30 PV systems in Ticino and the corresponding reduction in maximum power.

SUPSI carried out a field study in 2018-2020 on 30 residential PV systems in Ticino, funded by the Fondo Energie Rinnovabili (FER). Although the sample size is limited, the results provide valuable qualitative insights (Figure 1). Key findings include:

- **16.7%** of the analysed systems were affected by **permanent partial shading**
- **More than 50%** experienced **temporary partial shading**
- **Defects (i.e. discolouration and glass breakage)** were observed in a small portion of strings exposed to shading

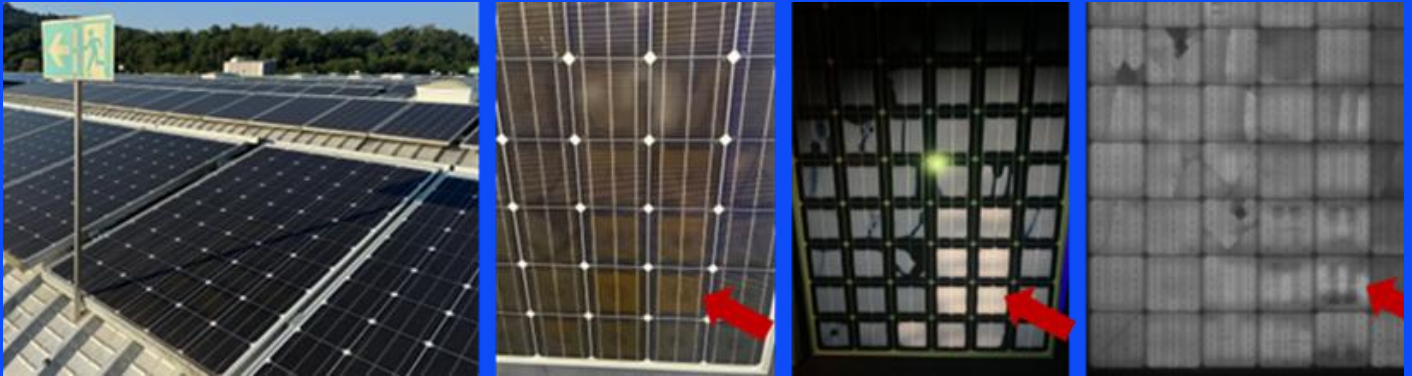
Persistent shading can trigger repeated bypass diode activation, leading to recurring hot spots in the same module area/s over many years. Even if peak temperatures remain moderate, repeated thermal stress can accelerate material ageing. This mechanism typically does not pose an immediate safety risk. However, it leads to additional long-term performance degradation, beyond the instantaneous energy loss caused by shading.

A case from Switzerland illustrates this effect in an Al-BSF module exposed to persistent partial shading for more than 11 years (Figure 2). The affected area showed:

- Accelerated encapsulant degradation
- Visible discolouration
- Corrosion of solar cells detected by electroluminescence imaging.

Accelerated encapsulant degradation produces acetic acid, which contributes to cell corrosion and results in permanent module degradation.

Figure 2: (a) Rooftop PV system exposed to persistent shading for more than 11 years; (b) encapsulant discolouration; (c) increased UV fluorescence indicating accelerated degradation; (d) corrosion visible in electroluminescence imaging.

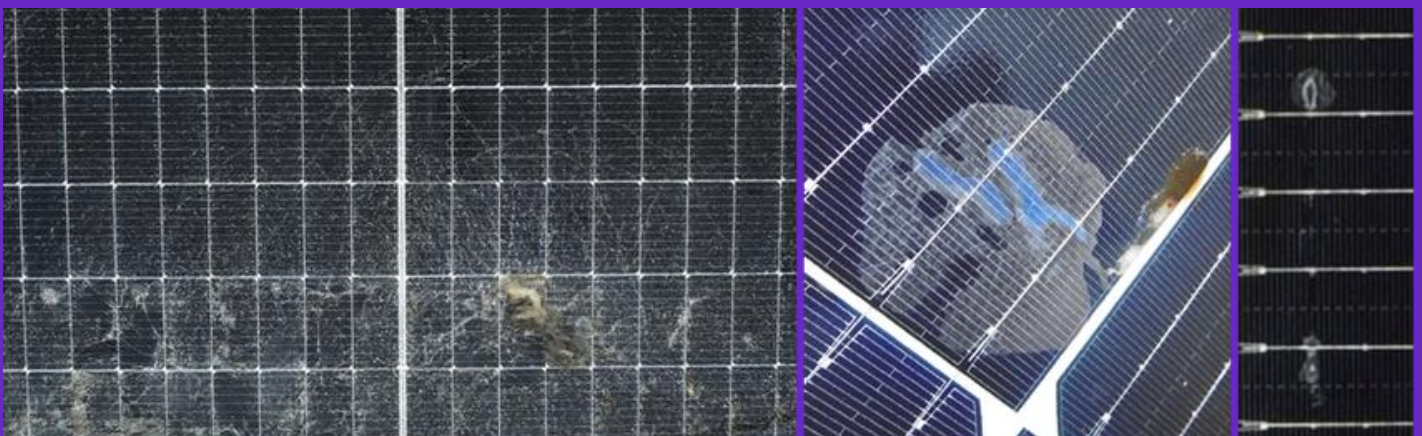
If the stress intensifies due to very high hot spot temperatures and frequent repetition, PV module components may fail. Possible damages with safety risks include delamination, glass breakage and bypass diode failure. Damage to a bypass diode results in a loss of its protective function. When a bypass diode fails in an open-circuit, intense local heating during shading events can pose a significant safety risk.

A case from a PV system in Switzerland illustrates this damage mechanism. Only the modules located close to a shading obstacle experienced high-risk damages (Figure 3). In these modules, bypass diodes exposed to continuous partial shading were damaged and could no longer protect the affected cell strings. As a result, continued partial shading after diode failure led to even higher hot spot temperatures, causing discolouration, delamination, glass breakage, and an increased safety risk. Although no serious incident occurred, the potential safety risk is evident.

No comparable damage was observed in the several hundred other modules within the same system that were not exposed to continuous partial shading.

Figure 3: Visual images of three modules removed from a persistently shaded area of a PV system. Modules in non-shaded areas showed no comparable damage.

Module and bypass diode testing under realistic operating conditions beyond current IEC standard test procedures

Appropriate module selection, electrical system design, and module placement, with explicit consideration of nearby shading objects

Use of monitoring systems with suitable alarms, regular inspections, and targeted maintenance of shading-affected installations
