# New Challenges with latest PV technologies

Insights from SUPSI PVLab R&D projects

SUPSI Industry day, Mendrisio, 21.05.2026

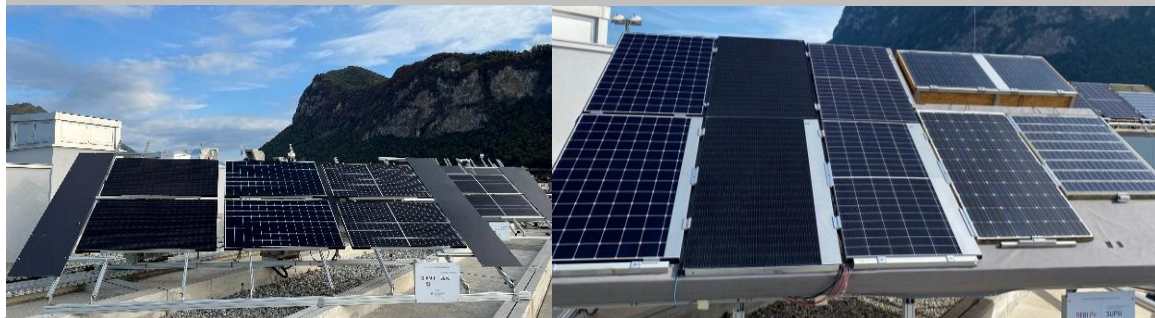
### MODULE TEST FACILITY

- Different configuration (open-rack vs. BIPV)
- Monofacial modules
- Test cycle 14 running and 15 starting
- 16 technologies and 48 modules

**Test cycle 14 (2021):** 4 PERC (2-cut, 3-cut, shingl., diodes), 1 HJT (SW 2-cut), 1 TOPCon BC (full cell), 1 TOPCon (2-cut)

**Test cycle 15 (2026):** 3 HJT, 3 TOPCon, 3 BC **NEW**

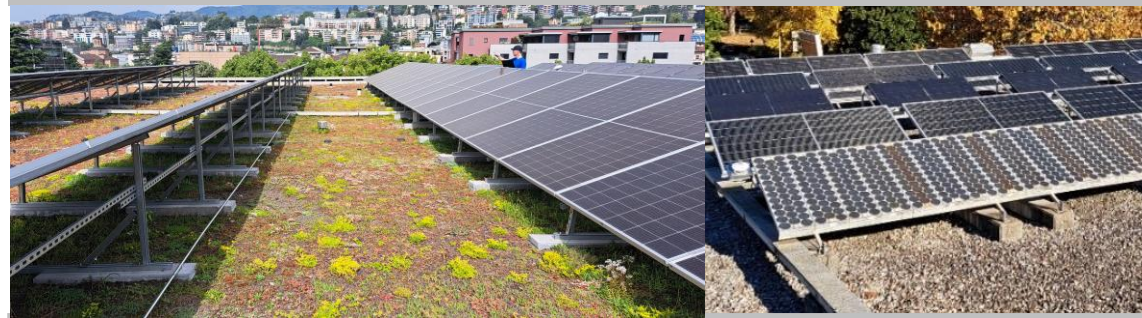
### SYSTEM TEST FACILITY

- 132 kWp (+ 16.74 kWp) roof-top system
- Monofacial vs. bifacial modules
- High voltage >1500V vs. low voltage strings
- 7 technologies and 28 reference modules

**Viganello (2022):** 2 PERC (2-cut), 1 PERC bifacial (shingl.), 1 TOPCon (2-cut), 2 TOPCon bifacial (2-cut), 1 HJT bifacial (SW 2-cut)

**Mendrisio (2023):** old TISO10, new low voltage strings

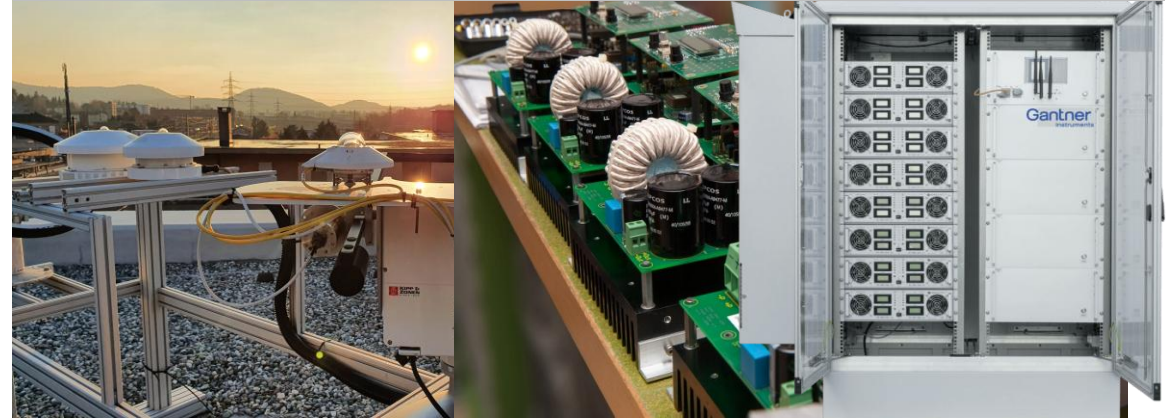
### FIELD MONITORING

- Module level IV curve tracers + MPP tracker
- Dark I-V measurement (string level monitoring) **NEW**
- Temperature sensors (PT100)
- Calibrated pyranometers
- Spectrum radiometer (EKO)
- Soiling sensors
- Meteo station

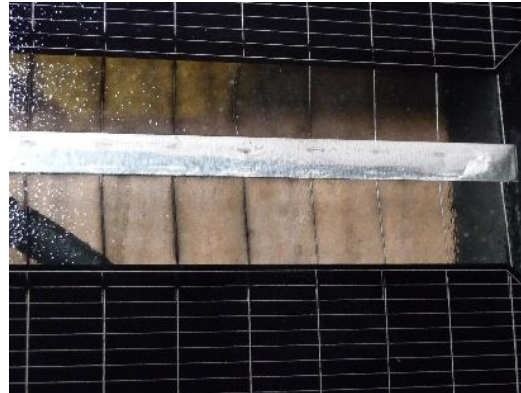
Viganello: HJT glass/glass module showing darkening of the contacts and delamination of fingers at the module border

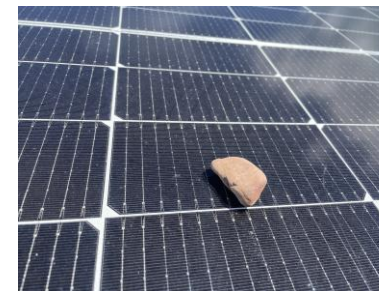
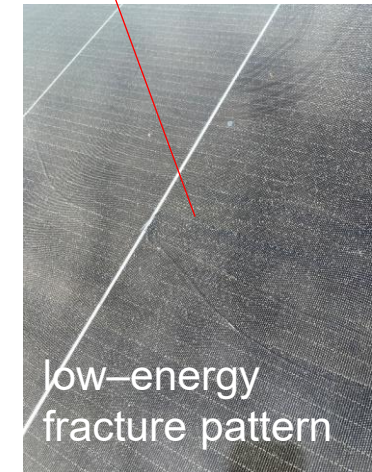
Repeated damage in same position: Shading induced?
