# **Alpine PV Modules: Mechanically Robust, Yet UV-Sensitive? Insights from Mechanical Load and UV Stress Testing**

SUPSI Industry Day 2026

Ebrar Özkalay, Gabi Friesen, Mauro Caccivio

21 May 2026

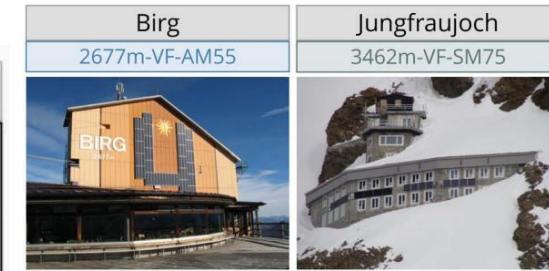
- High irradiance (*Front-side* >1600 W/m<sup>2</sup> from private discussions in CH)
- Front+Rear Irradiance >1800 W/m<sup>2</sup> expected
- High current due to high albedo + bifaciality
- **Stress on busbars/ribbons and bypass diode**

- High altitude → high UV
- Snow albedo is UV rich [1]
- **Stress on polymeric materials**
- **Stress on UV-sensitive solar cell technologies (i.e. TOPCon, PERC, HJT, BC)**

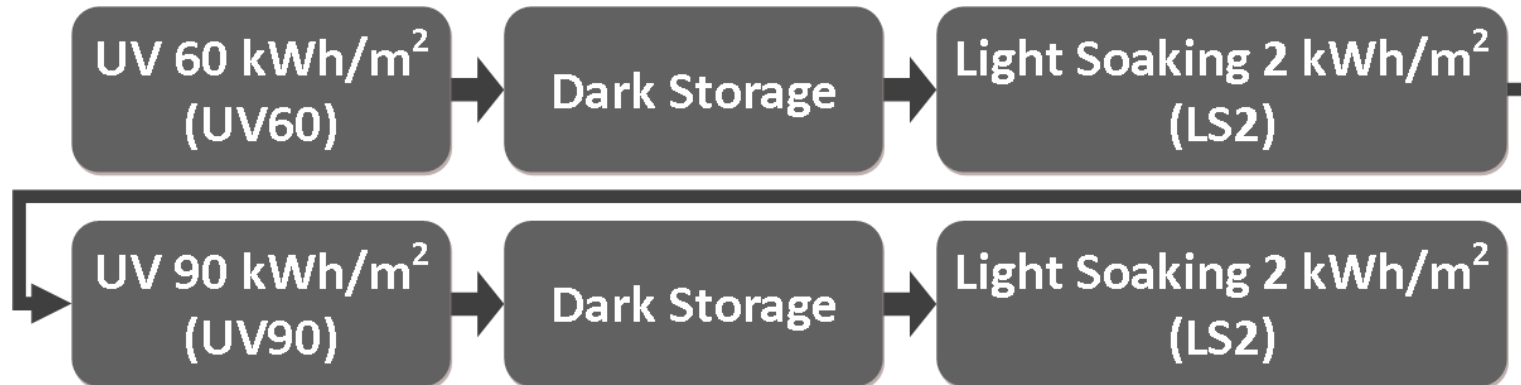
## Alpine PV Module Testing – UV Stress Test Sequence

- High UV irradiance
- High albedo (snow albedo is UV rich) + Bifaciality
- New technologies are UV sensitive (especially rear sides) <sup>[1,2]</sup>

- All modules show UV sensitivity.
- Significant degradation already at 60 kWh/m<sup>2</sup> (~2–4%), primarily from Voc and FF losses.
- After 150 kWh/m<sup>2</sup> exposure, total losses reach ~3.2–9%.
- Checkered EL pattern observed in all modules due to UVID.
