**Quality of solar modules – a practical view**

# PV Design Operation Quality

21 May 2026

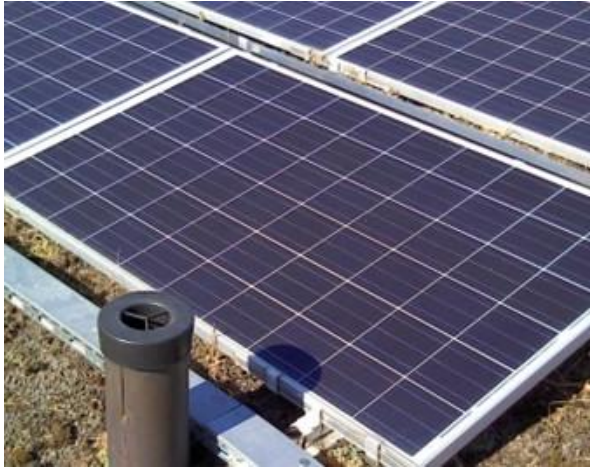
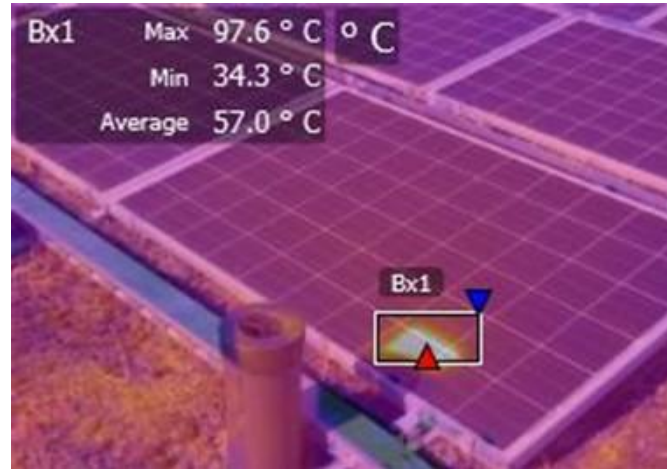
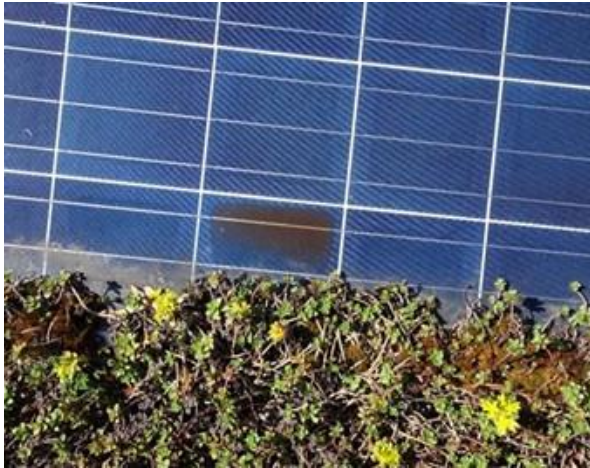
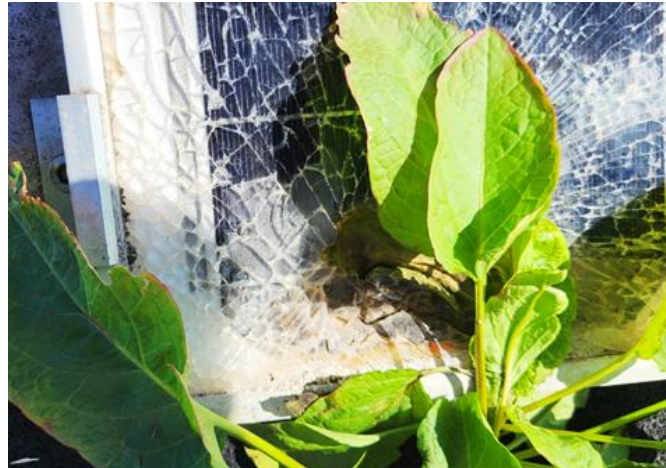
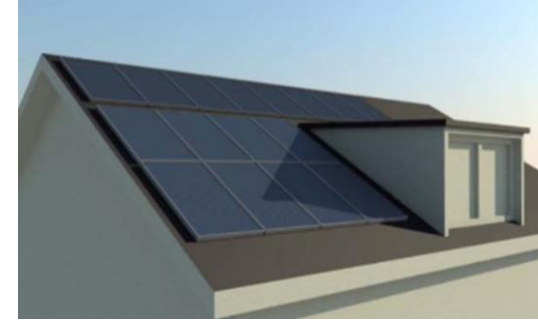
# Avoid Small Shadows, it can destroy the modules

- Large-area shading can be managed by the inverter
- Global MPP tracking
- Bypass diodes
- Optimizers

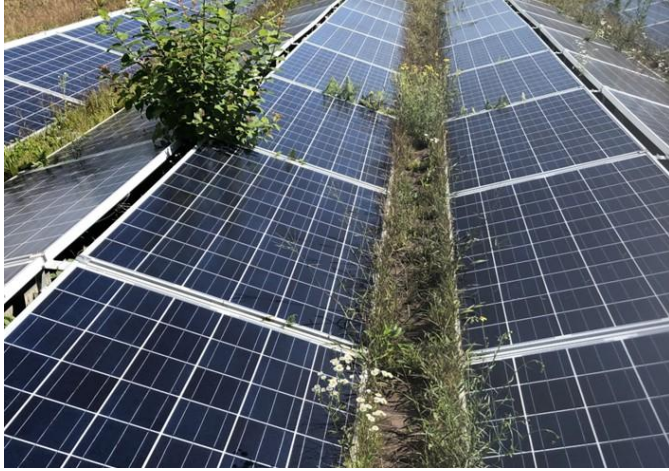
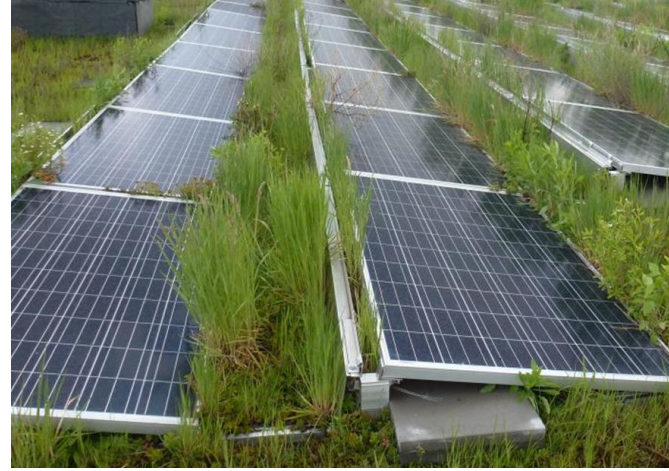
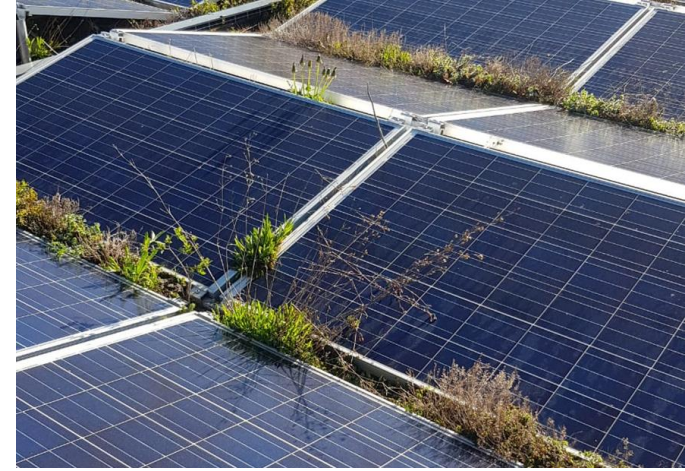
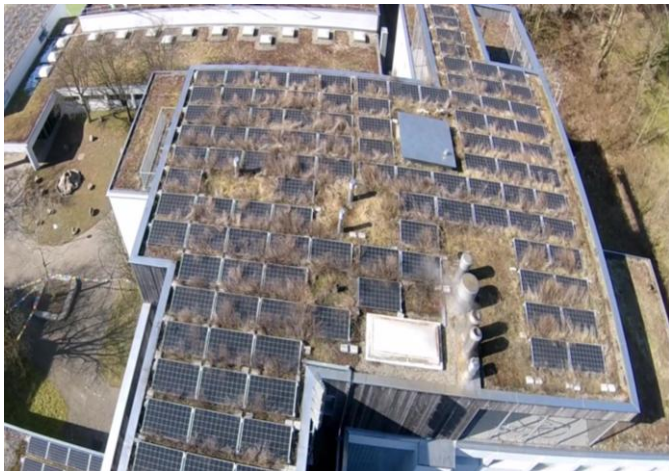
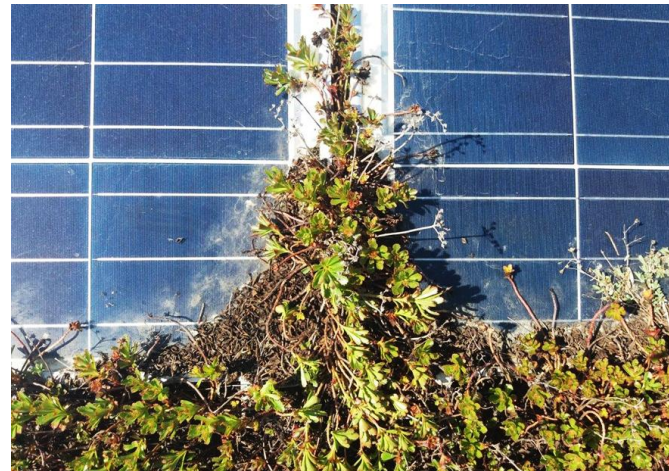
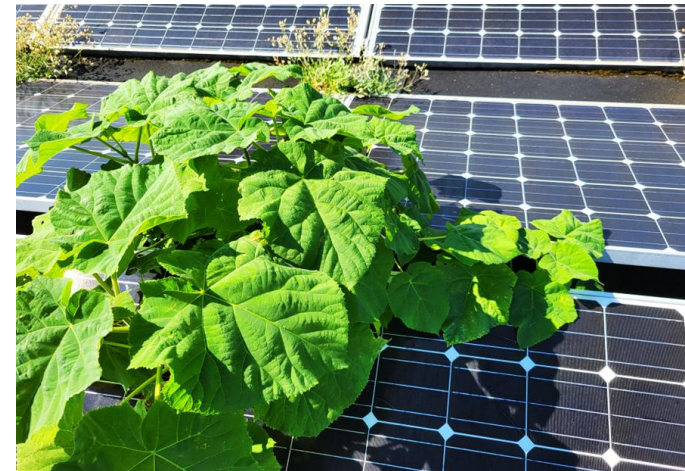
# Consider green roofs, no aerodynamic substructures

Merkblatt Swissolar «Dachbegrünung und Solarenergieanlagen»

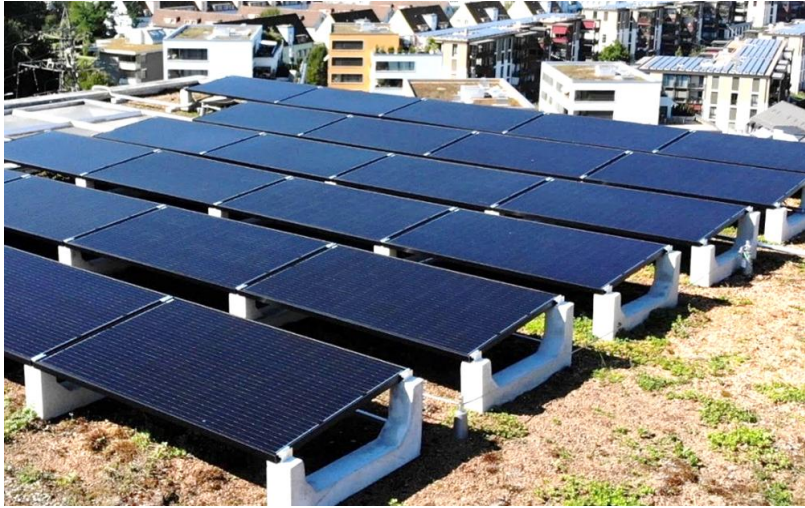
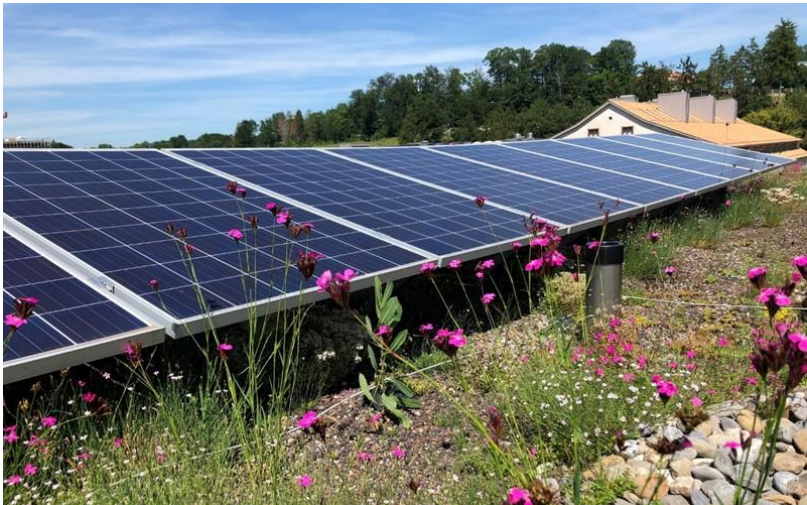
# There Is a Better Way for Green roofs— And It Pays!

- Green-roof-specific substructures only
- module bottom at least 35cm
- Larger row spacing
- Thin substrate layer

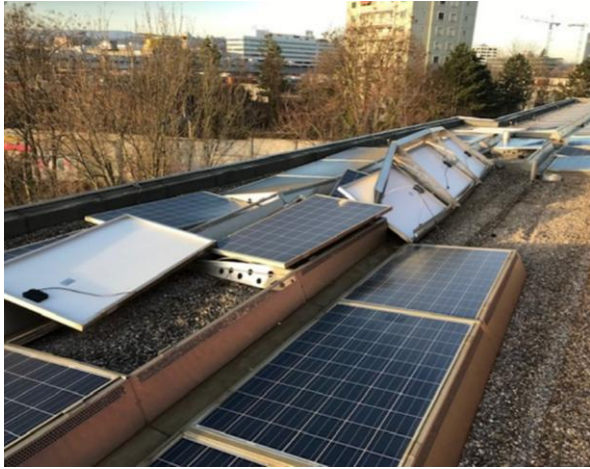
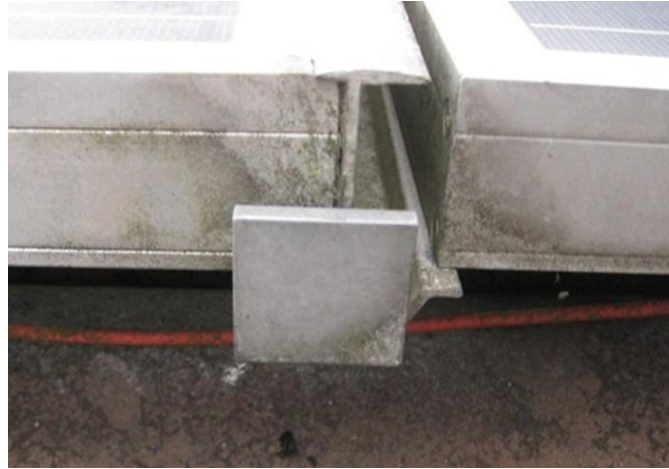
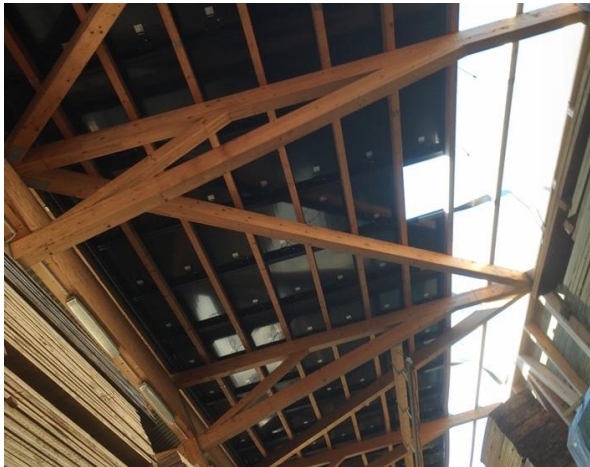
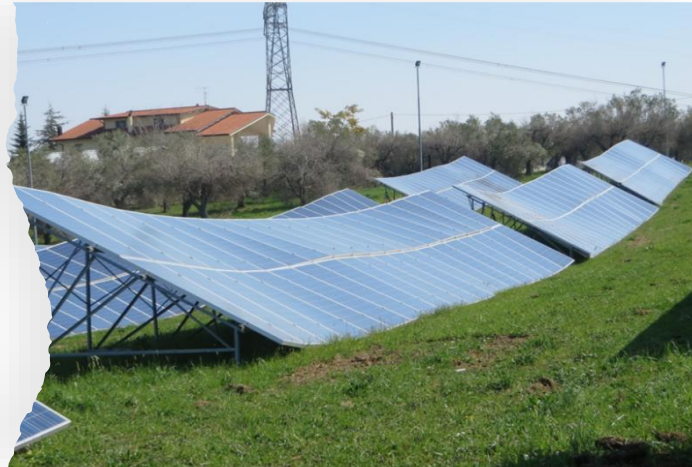
# Structural Engineering is crucial

- Location
- Building
- Roof
- Substructure
- Overhang
- Edge clearances
- Follow mounting plan (e.g., number of roof hooks)
- **Read Manufacturer specifications**
- Consider thermal expansion

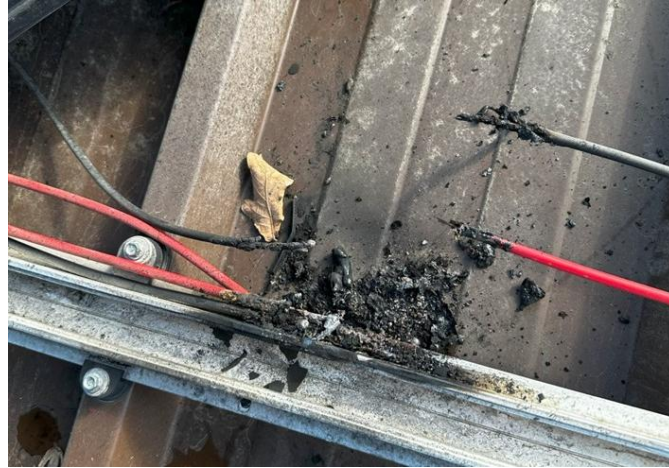
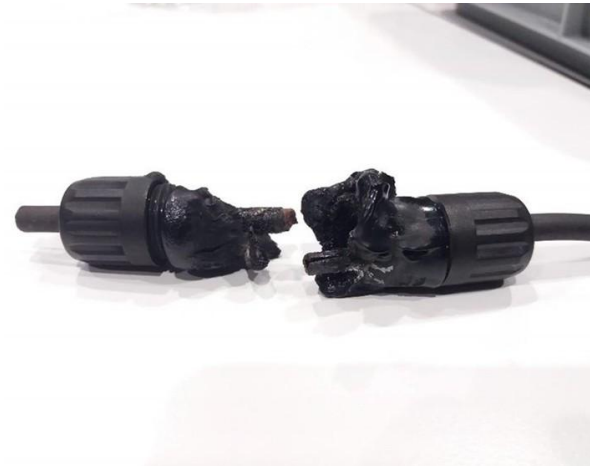
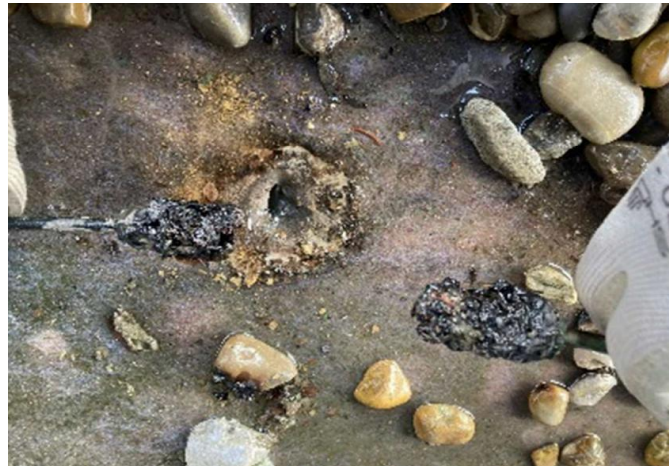
# PV Connectors Are High-Tech products

- No cross-brand connections
- Take care when crimping
- Use original tools
- Plug correctly and perform pull-test
- Connectors must not lie on the roof
- Do not leave open (NIN 2025)

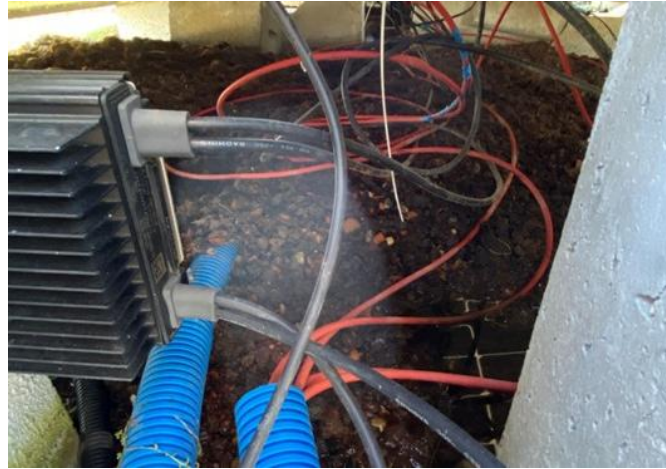
# Many considerations for cabling

- Maintenance-friendly
- UV-protected
- Water-protected
- Low-inductance wiring
- Observe minimum bend radius

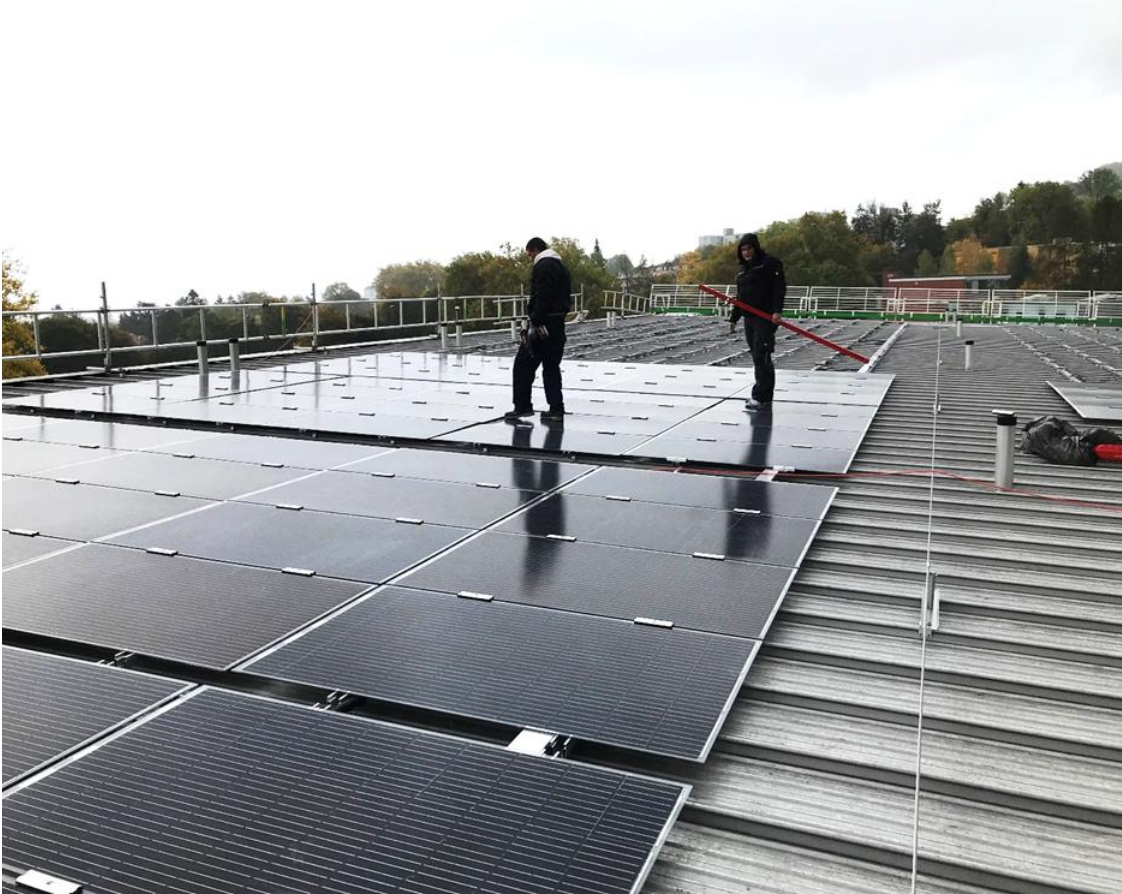
# Walking on modules **Prohibited !!!**

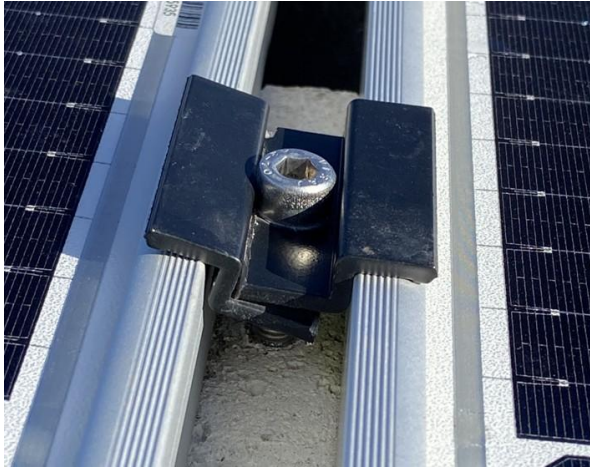
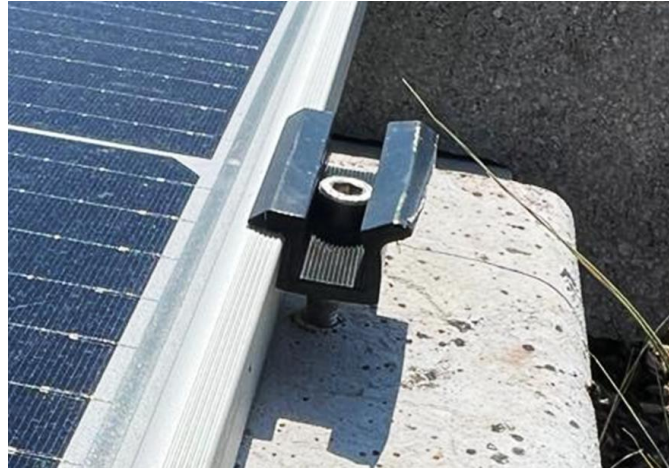
# Don't be lazy, the modules may fly away and kill people

- Install clamps correctly

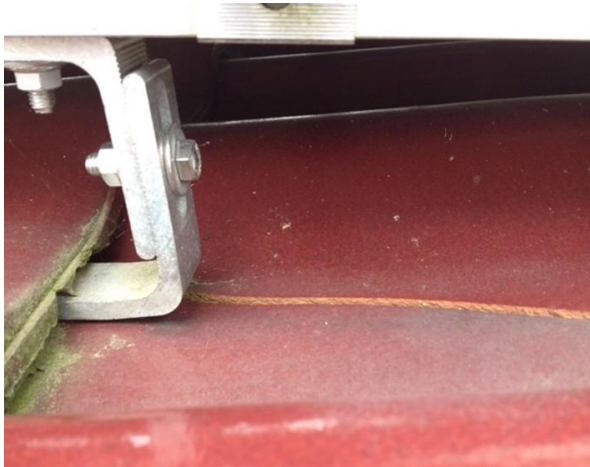
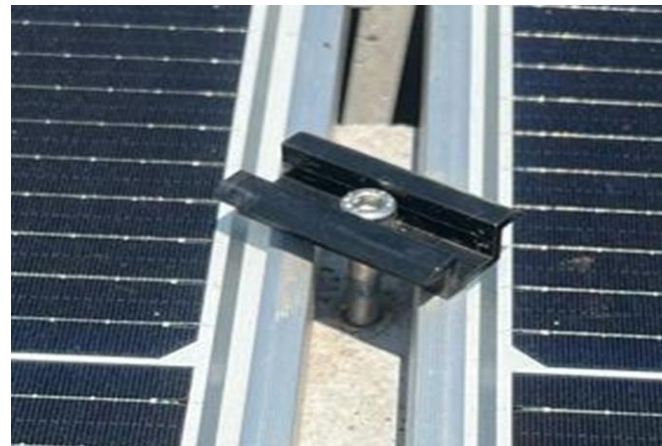
- Mount roof hooks properly

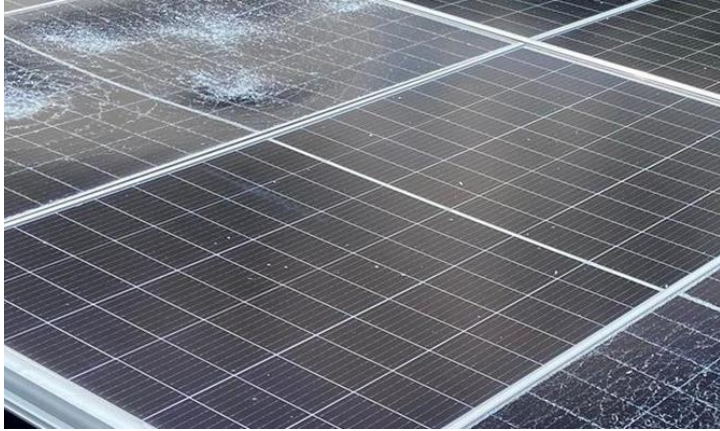
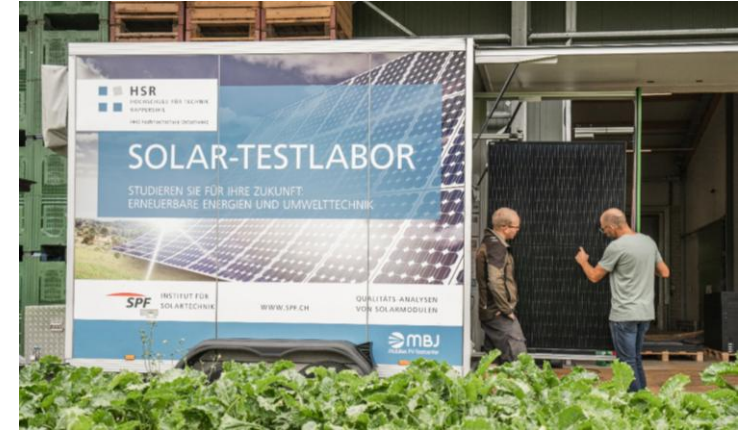
# Electroluminescence Testing, for example for hail damage testing

- A look "inside" the modules
- Making invisible cell defects visible

- Cell cracks (for example walking on modules)
- Inactive cells or cell areas
- PID
- Hail damage
- Transport and installation damage

- Modules are energized and light emission is measured
- In the lab
- Night/daylight EL
- Mobile PV lab
- Under test: drone supported EL

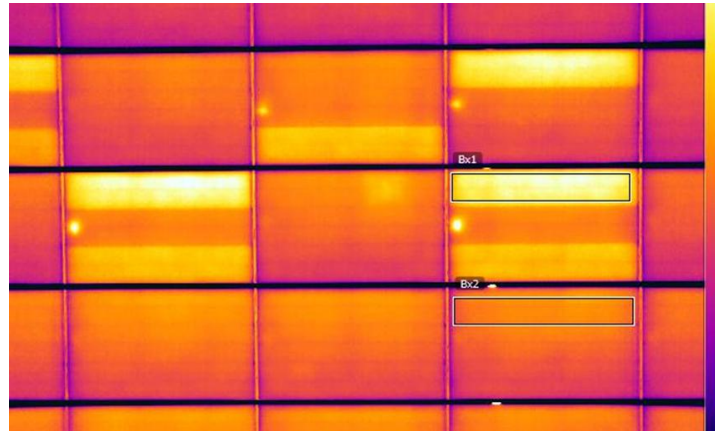
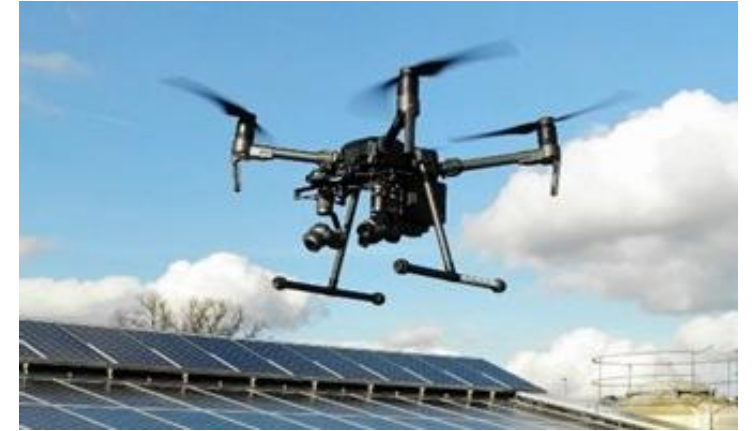
# Thermal imaging: one of the most powerful testing methods

- Measurement of surface temperature
- A lot experience is necessary for correct analyze
- AI-supported software is often better than human

- Modules and strings in open circuit, short circuit
- Defective substrings/diodes
- Hot spots
- Soiling, shading
- PID
- Glass breakage
- Cell mismatch

- Drone or handheld thermography
- Min. 600 W/m<sup>2</sup> irradiance
- Always with scale and reference photo

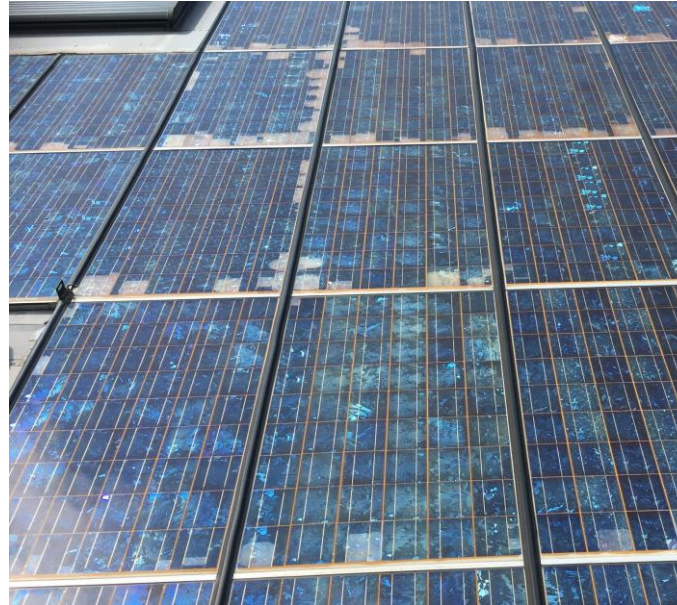
- Commissioning ??
- Delamination
- Image taken in 2020

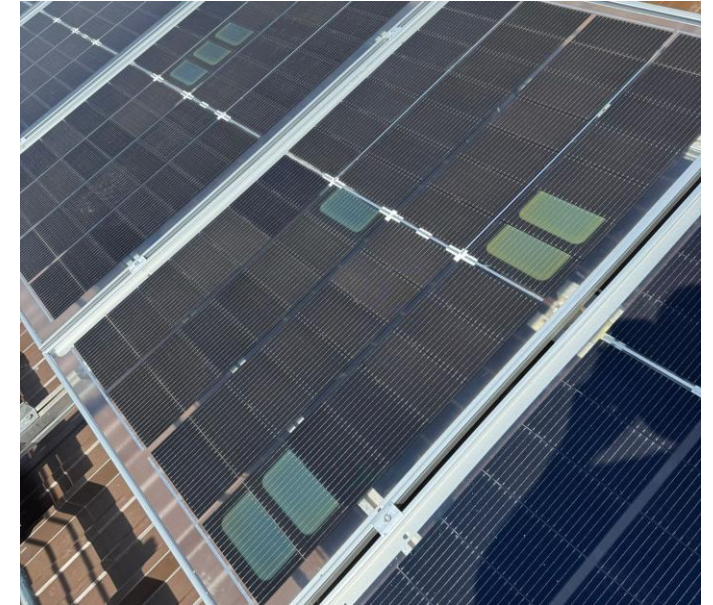
- Commissioning 2025
- Delamination
- Image taken in 2026

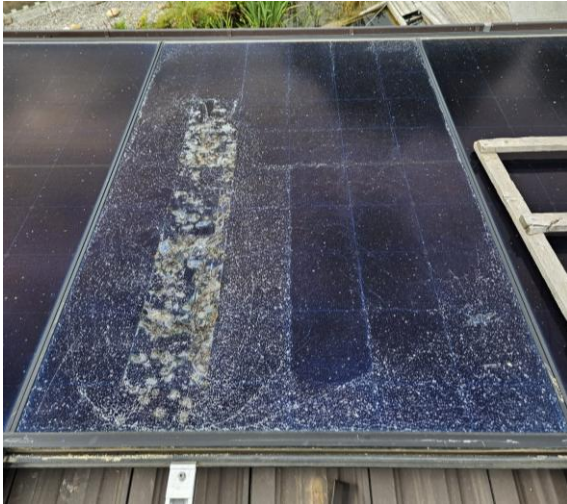
- Not connected bypass-Diode
- Module burned when shaded
- Commissioning 2024
- Image taken in 2025

PID and other problems  
Commissioning 2013  
Image taken in 2024

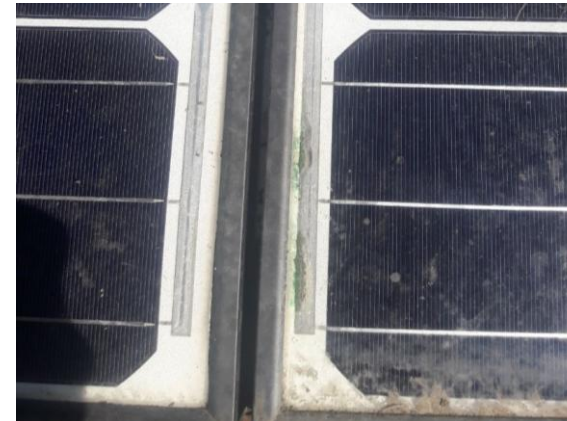
- Faulty backsheet (probably PET)
- Commissioning 2014
- Image taken in 2026
