Task 13 Performance, Operation and Reliability of Photovoltaic Systems

PV Failure Fact Sheets (PVFS) 2023

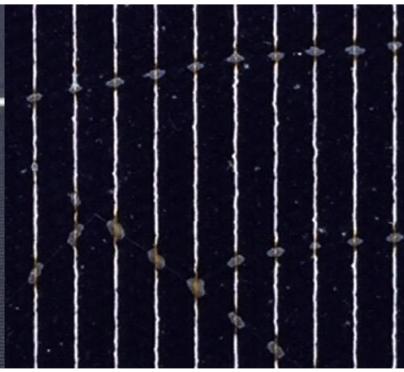
| EXAMPLES (page2) | | PVFS 1-1vs.01 | |
|---|--|--|---|
| | Zoom of snail track with delamination. [Yang19] | Zoom of snail track with browned fingers. [Sinclair17] | Zoom of snail track with delamination. [SUPSI] |

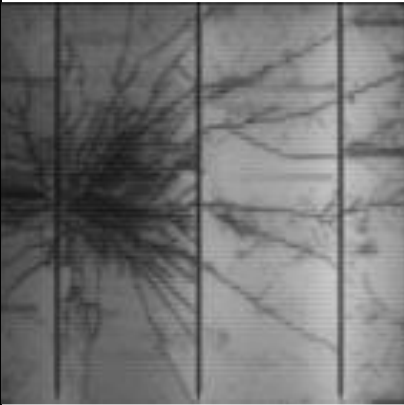
| EXAMPLES (page2) | | PVFS 1-1vs.01 | |
|---|--|--|---|
| | Cell crack with EVA delamination. [TUV Rheinland] (see also PVFS 1-3) | Typical EL picture of a cell crack caused by hail. [TUV Rheinland] | Repetitive crack pattern due to impact of soldering machine. [SUPSI] |

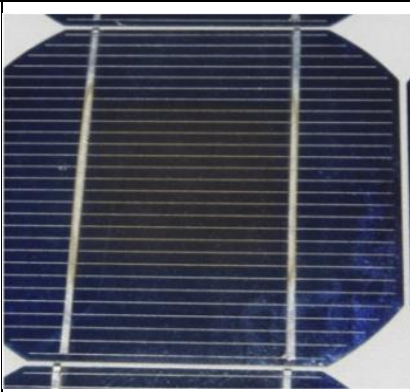
| | <p>Slightly browned EVA in the centre of the cell with photobleaching at the edges. [Köntges14]</p> | <p>Slightly browned EVA in the centre of the cell with photobleaching at the edges. [India18]</p> | <p>Yellowed backsheet from the inside. [Sinclair17]</p> | | | |

| Component Defect | Module | PVFS 1-2vs.01 | |
|---|---|--|---|
| | <p>Modules with a direct safety risk or a severity of 5 should be replaced. Regular inspections should be done to monitor the status of the not replaced modules.</p> | Check validity of IEC 61215 certification and BOM. | Regular system inspections For areas with harsh climate, request modules pass higher test standards, like double or triple IEC 61215 test condition. |

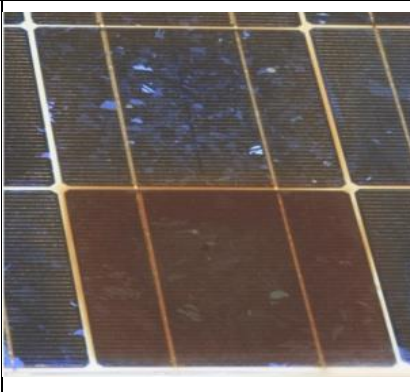
| | <p>Single cell browned much faster than the others due to local heating. [Köntges14]</p> | | | | | |

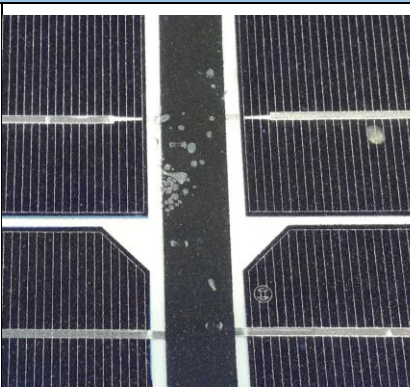
| | <p>Encapsulant delamination in un-critical position. [SUPSI]</p> | <p>Encapsulant delamination from cell caused by production process. [SUPSI]</p> | <p>Encapsulant delamination from cell along grid fingers and bus bar. [Packard12]</p> | | | |

| Component Defect | Module | PVFS 1-3vs.01 | |
|---|--|---|--|
| | Modules with a direct safety risk or a severity of 5 should be replaced. Regular inspections should be done to monitor the status of the not replaced modules. In case of individual module testing all modules which failed the insulation and/or wet-leakage test should be replaced. | Check validity of IEC 61215 certification and BOM, ground fault detection by inverter or other devices at all time. | Extended testing (e.g. damp heat), pre-shipment inspections (e.g. cross linking level of EVA) regular visual system inspections. |

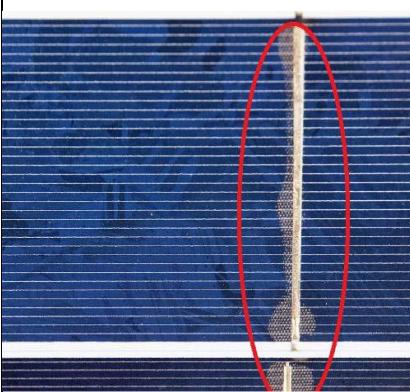
| | <p>Encapsulant delamination from glass (spotted due to glass texture) along the bus bars. [Packard12]</p> | <p>Encapsulant delamination along a cell crack. [Köntges16] (see also PVFS 1-1)</p> | <p>Encapsulant delamination near cell edges in combination with cell browning. [Packard12]</p> | | | |

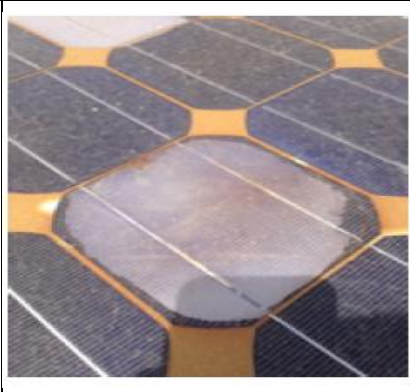
| | <p>Delamination in front of cell in the centre of the module. [Moser17] (see also FS 1-2)</p> | <p>Delamination at module insert connections of a glass/glass module (junction box). [SUPSI]</p> | <p>Delamination at cell edges. [Köntges14]</p> | | | |

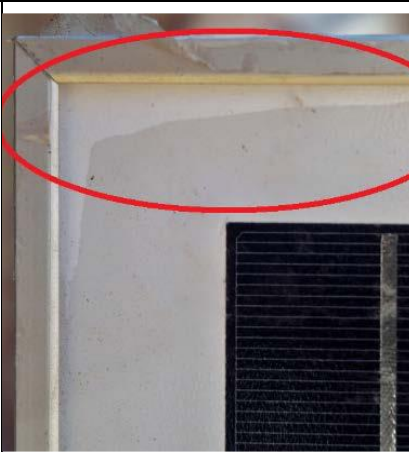
| | <p>Encapsulant delamination at borders. [Sinclair17]</p> | <p>Encapsulant delamination along a bus-bar in a cell close to the module edge. [Moser17]</p> | <p>Encapsulant delamination of from glass (spotted due to glass texture) at the edge of the cell. [Sinclair17]</p> | | | |

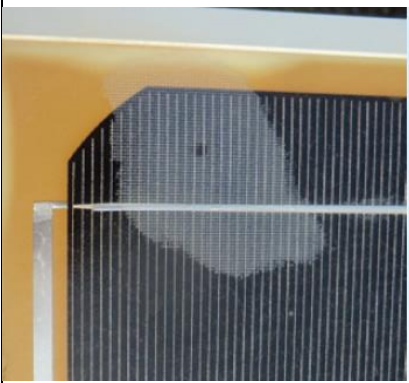
| | <p>Delamination creating a continuous path between electric circuit and the edge. [Moser17]</p> | <p>Delamination with corrosion. [Köntges17] (see also FS1-11)</p> | <p>Delamination caused by detachment of backsheet with exposure of encapsulant from the back. [SUPSI]</p> | | | |

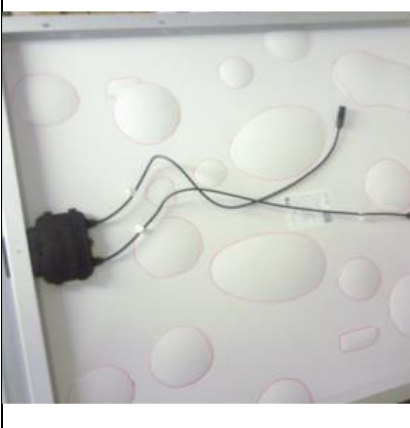
| <p>Multiple bubbles in the centre and edge of the backsheet. [Köntges16]</p> | <p>Blisters because of vapour barrier, such as aluminium foil. [Köntges17]</p> | <p>Big central bubble + wavy delamination. [Köntges14]</p> | |

| Component Defect | Module Backsheet delamination | PVFS 1-4vs.01 | | | |
|---|---|--|---|---|---|
| | Modules with a direct safety risk or a severity of 5 should be replaced. Regular inspections should be done to monitor the status of the not replaced modules. In case of individual module testing all modules which failed the insulation and/or wet-leakage test should be replaced. | Check validity of IEC 61215 certification and BOM. Ground fault detection by inverter or other devices at all time. | Regular system inspections. | | |

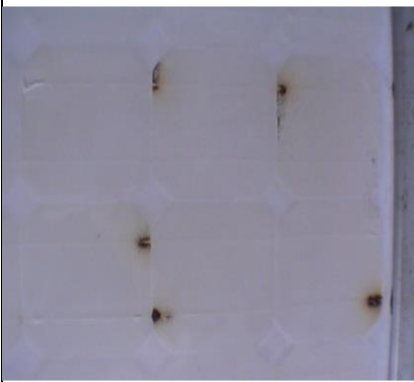
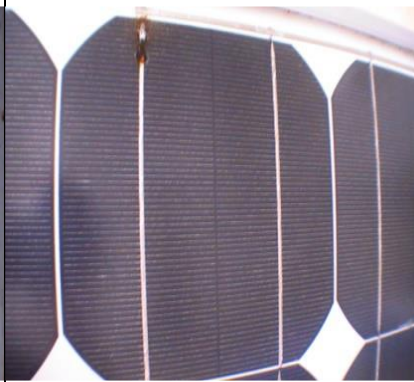
Front and back side view of burn marks caused by open-circuited bypass diodes and current mismatch conditions (due to shading or cracked cells). [Köntges14]

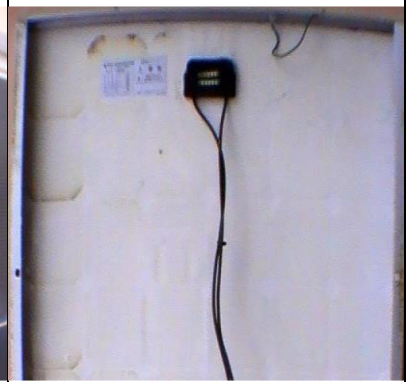
Burn marks caused by defect bypass diodes or an interconnect failure in the junction box. [Köntges14]

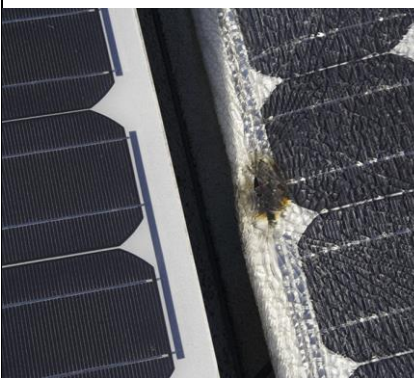
Burn mark with broken glass caused by poor bussing ribbon soldering. [Yang19] (s. also PVFS 1-8 and PVFS 1-8)

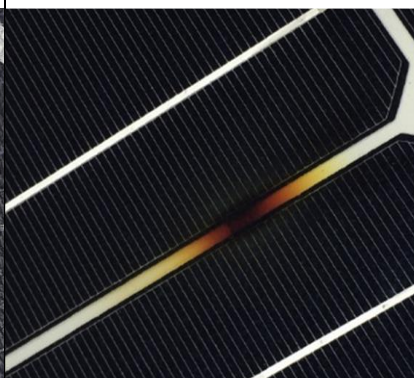
Burn mark due to intrinsic shunting caused by error in manufacturing process. [Yang19]

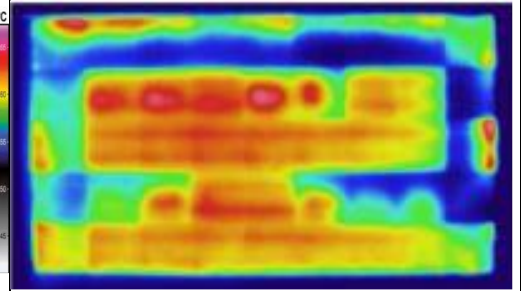
Dark IR thermography at I_{sc} for a module affected by PID. [Köntges14]

| Component Defect | Module Potential induced degradation (PID) (page2) | | PVFS 1-10vs.01 |
|---|---|--|--|
| | <p>How to proceed depends very much on the stage on which PID is detected. If detected in an early stage recovery is possible by applying a reverse voltage during night-time. Specific anti PID kits are available on the market promising a recovery of the lost power. As there is not a full guarantee that the recovery will be effective for the specific situation, it should be monitored or measured to see if the problem has been sufficiently solved. In the case of progressed PID without visible module damages, the recovery could need several months or even years suggesting in any case a replacement of all modules with modules tested to be PID resistant.</p> | <p>Modules tested for PID accord. IEC 62804-1 should be less prone to PID (verify that BOM corresponds!)</p> | <p>PID prevention at system level: The installation of an inverter with transformer can be considered as mitigation measure for the PID phenomenon. On the other hand, the trade-off with the inverter efficiency and the cost of the inverter must be taken into account. Anti-PID insurance.</p> |

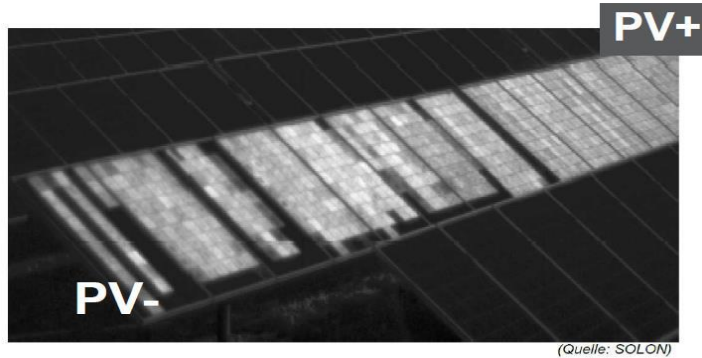
Strings with PID, detected with EL imaging.

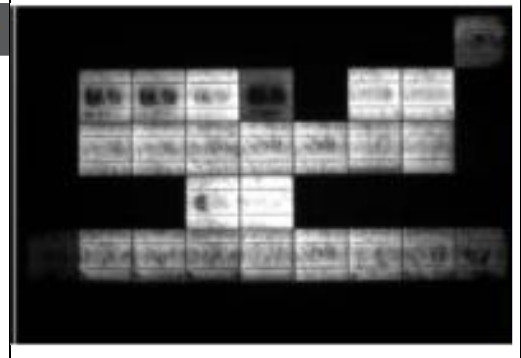
Electroluminescence image made at I_{sc} for a module affected by PID. [Köntges14]

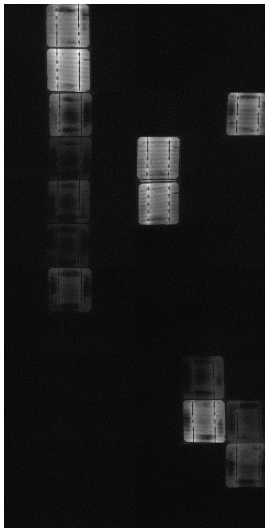
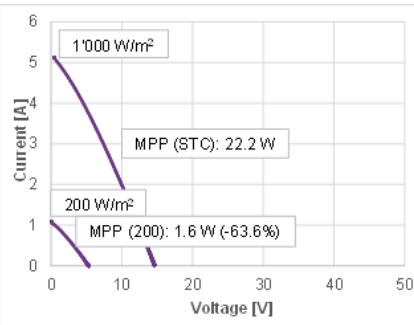
PID affected module with power loss of 89%, left: EL at $1.5 \times I_{sc}$, right: I-V curve of the same module at 1000 and 200 W/m². [Herrmann21]

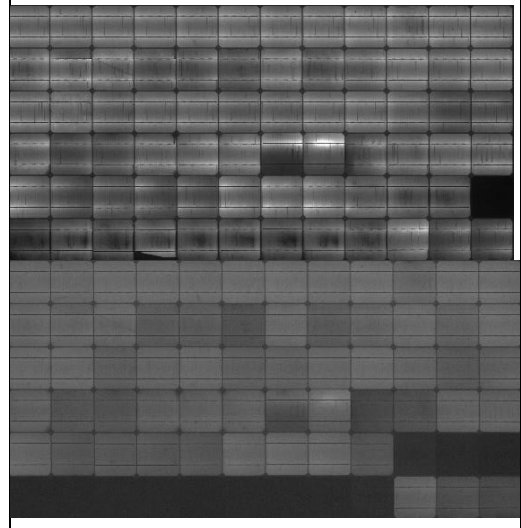
PID affected module with power loss of 14%. top: EL at $1.5 \times I_{sc}$. bottom: EL of the same module at $0.2 \times I_{sc}$. [Herrmann21]

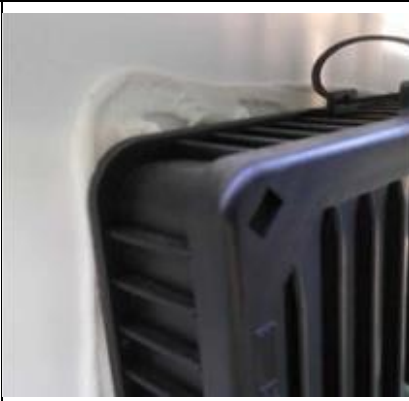
| | <p>Poorly bonded junction box on the backsheet. [Köntges14]</p> | <p>Open junction box in the field. [Yang19]</p> | <p>Detached junction box from backsheet. [SUPSI]</p> | | | |

| Component Defect | Module Defect or detached junction box | | PVFS 1-13vs.01 |
|---|--|--|---|
| | Modules with a direct safety risk or a severity of 5 should be replaced or repaired. Regular inspections should be done to monitor the status of the not replaced modules. | Check validity of IEC 61215 certification and BOM. Ground fault detection by inverter or other devices at all time. | Regular system inspections. |

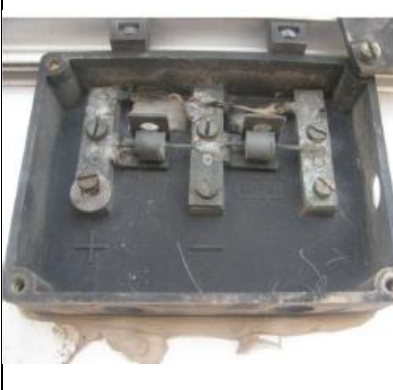
| | <p>Left: Missing junction box lid sealing with corrosion of contacts. Right: Good junction box sealing. [India13]</p> | | <p>Missing seal or strain relive of module cables, improper cable inlet. [Sinclair17]</p> | | | |

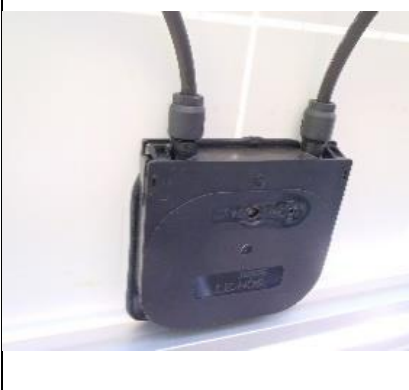
| | <p>Melted junction box. [TUV Rheinland]</p> | <p>Burned junction box caused by corroded contacts within the junction box. [TUV Rheinland]</p> | | | | |

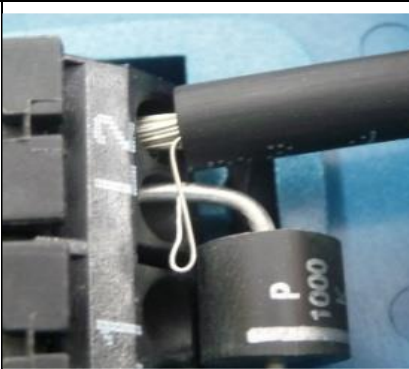
| | <p>Junction box with poor wiring. [Köntges14]</p> | <p>Detached tabbing ribbon due to bad soldering. [Köntges14]</p> | <p>Corrosion failure due to water soaking of the IP65 rated Jbox. [Yang19]</p> |

| Component Defect | Module | PVFS 1-14vs.01 | |
|---|--|--|--|
| | Modules with a direct safety risk or a severity of 5 should be replaced. Regular inspections should be done to monitor the status of the not replaced modules. | Check validity of IEC 61215 certification and BOM. Ground fault detection by inverter or other devices at all time. | Testing of modules with mobile test centre before installation, regular system inspection, installation of arc detection tool. |

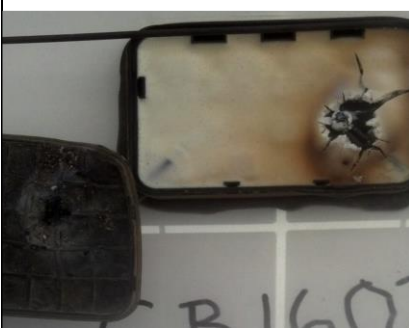
| | <p>Jbox failure due to poor electric connection. [Yang19]</p> | <p>Evidence of loose screw connection inside Jbox with browning of pottant. [Yang19]</p> | <p>Cold soldering of module busing ribbon to the Jbox connection terminal pad with minor browning of pottant. [Yang19]</p> |

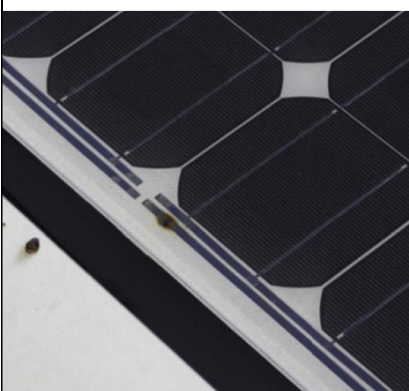
| | <p>Overheating due to the poor Jbox interconnect leading to light discoloration and burn mark on front and back side. [Yang19]</p> | <p>Overheating due to the poor Jbox interconnect leading to burn mark and glass breakage. [Yang19]</p> | <p>IR imaging of a hotspot Jbox due to loose electric connection inside. [Yang19]</p> |

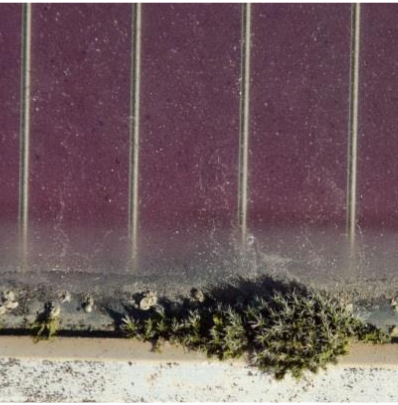
| | <p>Moss growing on the edge of a module combined with edge soiling. [Köntges17]</p> | <p>Soiling pattern on a system in the Atacama desert. [ISE]</p> | <p>Soiling pattern demonstrating dominant wind direction on a test site in Atacama desert. [ISE]</p> |

| Component Defect | Module Soiling | | PVFS 1-20vs.01 |
|---|--|--|--|
| | Cleaning by qualified persons is recommended when the revenue lost because of the missed energy production is higher than the cleaning cost. A best time to clean should be defined. | Preliminary site inspections for the assessment of the soiling risk. Cost estimation for the implementation of mitigation measures. Regular visual inspections to control the soiling level. | Estimation or measurement of soiling losses prior to installation. Installation of soiling sensors to determine the most profitable time to clean. |

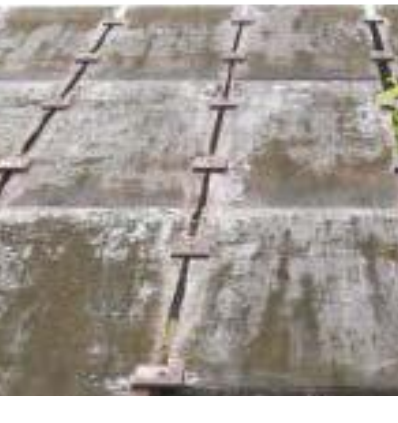
| | <p>Heavy biofilm soiling. [Köntges16]</p> | | |

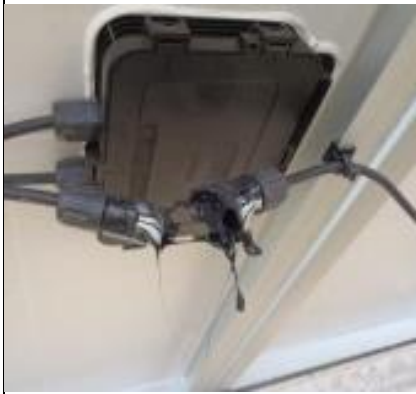
Burned connector. [Köntges17]

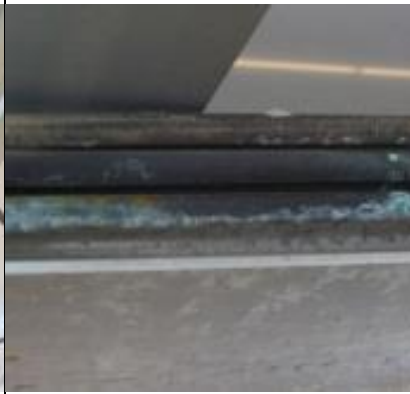
Corroded Cable. [Köntges17]

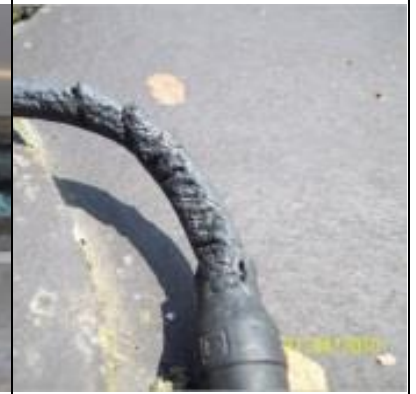
Animal bite on cable. [Köntges17]

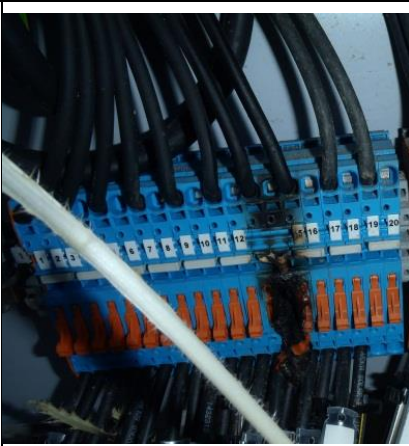
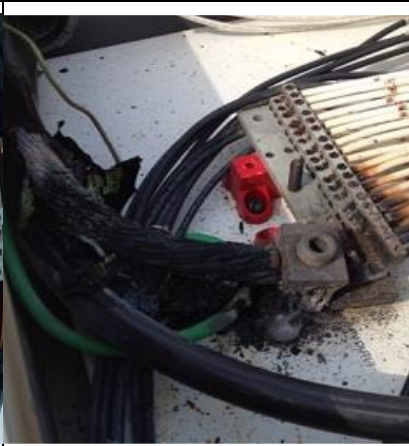
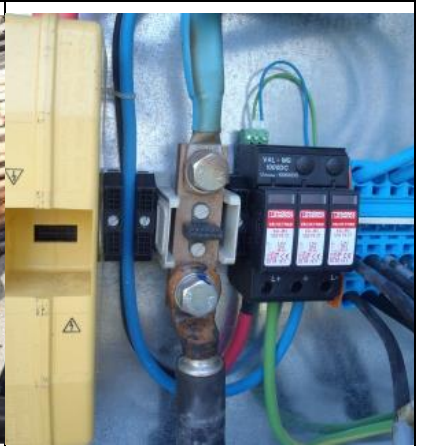
| <p>Examples 1-3</p> | | | |

| <p>Connecting terminals show signs of burning, have melted or charred. [TUV Rheinland]</p> | | | |

| Component Defect | Cables and Interconnectors | | FS 2-4vs.01 |
|---|---|--|---|
| | Replace the components with defect or abnormal temperature. | Use IRT to check the components and connection to find poor connection or defect components. | |

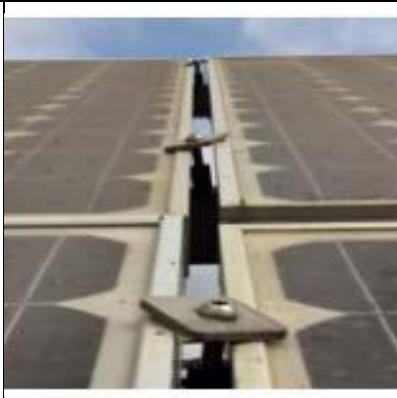
| <p>Examples 1-3</p> | | | |

| Origin | The installation instructions of the module and mounting structure from the manufacturer are not followed. Typical errors at the planning and installation stage are: (a) use of inadequate clamps for the selected module and/or mounting structure, e.g. sharp edges damaging glass/glass modules, wrong combination of clamps and modules or mounting structure (b) too short and too narrow clamps or (c) the positions, kind or number of the clamps on the module not being chosen in accordance with the manufacturer's manual. Other errors are too excessively or insufficiently tightened screws during the mounting phase. | | |
| Impact | An improperly installed clamp compromises the integrity of the mounting system and the ability of the module to stay in place under high wind or load conditions. The detachment of modules can happen as series effect because the modules share the clamps with the module next to it. Once one module is detached, the clamp immediately loses fixing force on the next module and result in series detachment. The detachment of the module/s from the mounting structure is posing a serious hazard to persons and the risk of damaging the rest of the system and/or the property in the vicinity of the installation site. Problems such as frame damage, glass breakage or cell cracks can occur compromising on the long term the performance and the electrical safety. | | |

| | <p>Improper installation of clamp.</p> | <p>Wrong combination of clamps and modules. [Moser17]</p> | <p>Glass breakage caused by too tight screws. [Herrmann21] (see also PVFS 1-8)</p> |

| | Modules with a safety risk or a severity of 5 should be replaced. | Use only compatible clamps (mounting structure/ modules/ clamps) and follow manufacturer mounting instructions. Check local wind and snow loads. | Testing of non-standard mounting configurations by an accredited test laboratory (eg. facade mounting), perform regular system inspections |

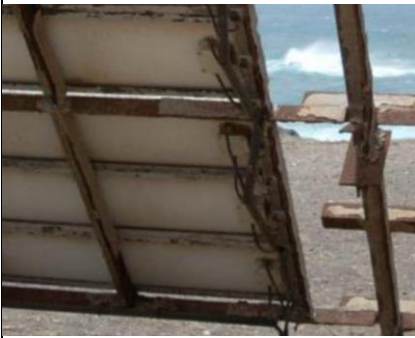
| <p>Examples 1-3</p> | | | | | | |

| Origin | Typically, this failure occurs when the mounting structure is not designed to withstand the wind or snow loads which are typical for the site in which the system is installed (e.g. mounting structure does not comply with static calculations, underestimation of the environmental conditions), or if the anchorage of the mounting structure to the ground or roof is weak (e.g. ground conditions are not considered sufficiently when choosing the mounting structure). The roof strength, to withstand the added load of the PV system and include allowance for O&M activities, is not verified. Another reason for the failure of a mounting structure is the use of inappropriate materials (e.g use of corrosive materials in a corrosive environment, insufficient galvanisation, poor quality material due to a bad or missing quality assurance in production), leading to a premature degradation or mechanical failure of the mounting structure. Installation errors (e.g. missing/non-original components, excessively or insufficiently tightened screws) can be the origin of a failure of the mounting structure. | | |

| | <p>Corrosion due to salt water. [Köntges16]</p> | <p>Cracks in mounting structure due to mechanical stress. [Köntges16]</p> | <p>Screw canal bends due to mechanical stress. [Köntges16]</p> | | | |

| | Mounting structures with a direct safety risk should be replaced or repaired. | Use only compatible mounting structures (ground/mounting structure/modules) and follow manufacturer mounting instructions. Check local load (conditions (wind, snow, other). | Regular system inspections. Testing of non-standard mounting configurations by an accredited test laboratory (e.g. facade mounting), perform regular system inspections. |

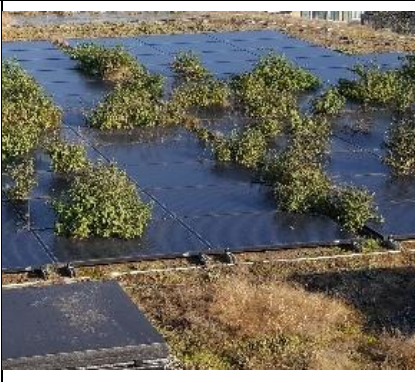
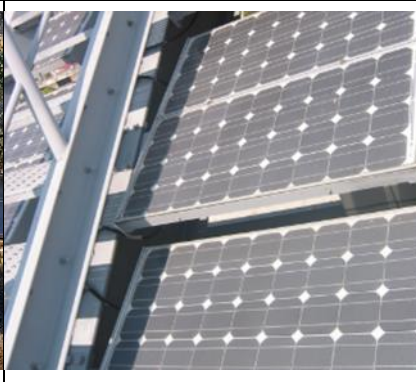
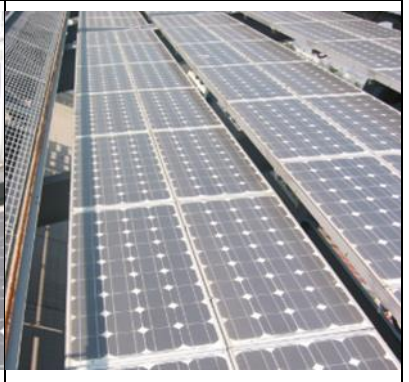
| <p>Examples 4-6</p> | | | | | | |

| Component Defect | Mounting Module shading | | PVFS 3-3vs.01 |
|---|---|--|---|
| Origin | The choice of the mounting structure and the position in which the modules are mounted influences the shading conditions. Shading can be caused by different factors or obstacles e.g trees, antennas, poles, chimneys, satellite dishes, roof or façade protrusions, near buildings, cables, or by self-shading (inter array or row-to-row shading) or soiling. Shading conditions can change over the lifetime of a PV system due to growing vegetation, new constructions or construction elements. It can be distinguished between different types of shades: direct shades hindering the direct light to reach the module or diffuse shades. | | |
| Impact | A cell or module which does not receives or receives less sunlight due to a shading obstacle, lowers the performance of a PV system. Typically, the cumulative annual shading loss of PV systems is between 1-5%, but energy losses up to 20-30% can be observed for roof top or façade systems. Due to series connection of cells and modules, the power loss is significantly higher than the shaded area. The final loss depends on the on-site implementation or shading mitigation measures like optimised string and module arrangements (landscape mounting), use of module-level power electronics (MLPEs), inverter characteristics (MPPT search algorithms, string control) or the use of shading tolerant module technologies (e.g half-cut cells, back contact cells). Shading itself does not pose a safety issue, but the hot-spots caused by prolonged shading can lead to follow-up failures (e.g burn marks , bypass diode failures , glass breakage , arcing or fire). It further can result in an acceleration of the aging process resulting into higher degradation rates. The right time to consider the impact of shading is at the system planning phase, later it is usually too late. The use of MLPEs such as micro-inverters and DC optimizers for individual modules can potentially increase performance under shading conditions, but the gain achieved by these devices do not always exceeds the loss caused by the MPLE device itself (lower efficiency), and the shading still activates the bypass diode and result in hot spot on the shaded cell, which increases the risk of reliability issues. The choice of using them only in the area where shading occurs should be considered an alternative to install them for all modules. A cost benefit analysis should be done in any case. | | |

| Component Defect | Mounting Module shading | | PVFS 3-3vs.01 |
|---|---|--|---|
| | Indirectly damaged modules with a safety or severity risk of 5 should be replaced or repaired. Eventual trees or vegetation responsible for the increased shading loss should be cut. | A basic shading analysis (full year solar/shade data) is recommended to identify areas and periods of major shading. Areas exposed to shading within the central part of the day or sunny season should be avoided or appropriate/cost-effective shading mitigation measure should be implemented. | A detailed shading loss analysis should be done which estimates and compares different system configurations and shading mitigation measures. Perform regular system inspections. |

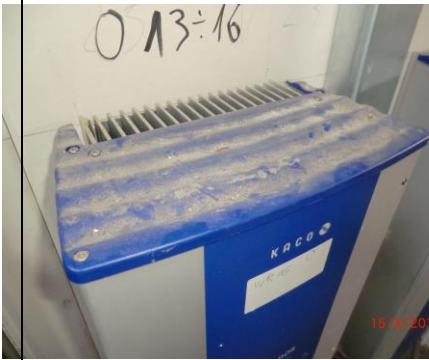
| <p>Examples 1-3</p> | | | | | | |

| Component Defect | Inverter Overheating | | | PVFS 4-1vs.01 |
|---|--|--|---|---|
| Origin | Temperature derating of the inverter can occur for various reasons, e.g. improper installation of the inverter, fan failure, dust blocking heat dissipation or an incorrect programming of the inverters. | | | |

| | <p>Dust blocking heat dissipation [TUV Rheinland]</p> | <p>A soiled air filter causes over-heating [TUV Rheinland]</p> | <p>Installation not appropriate (direct exposition to sun) [TUV Rheinland]</p> | | | |

| Component Defect | Inverter Overheating | | | PVFS 4-1vs.01 |
|---|--|--|---|---|
| | Once identified the origin of the temperature derating the failure should be repaired. The filters and in general heat dissipation path should be cleared of obstruction. | Follow the given installation procedure, use of adequate cooling technology, perform regular inspections of the ventilation units. | Monitoring of inverter temperature | |

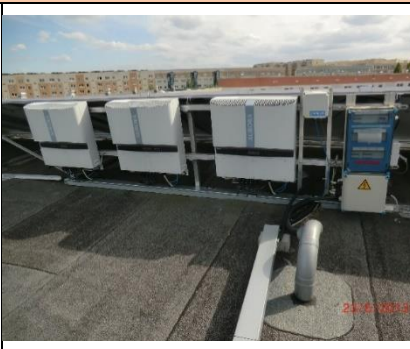
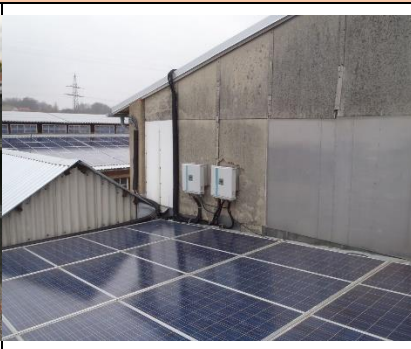
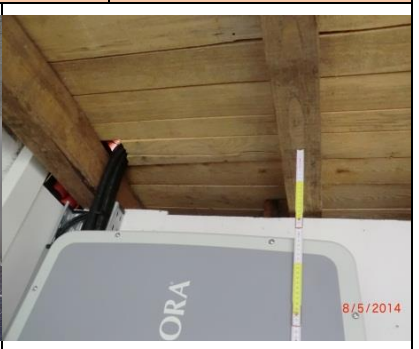
| <p>Examples 1-3</p> | | | | | | |

| Component | Inverter | | | PVFS 4-2vs.01 |
|---|--|--|---|---|
| Appearance | The inverter must be installed according to the installation instruction. A common failures is the installation near flammable, explosive, corrosive or humid sources. Also the minimum distances to bottom, top or to the sides are not always fulfilled. If the input cables are not fixed properly, increased temperatures can occur at the loose contact point which lead to lower performance or risk of fire. Inverters must always be accessible for operation and maintenance and properly secured to an appropriate base. | | | |
| Impact | Incorrect installation of the inverter can cause danger to users and hazardous conditions and can result in overheating of the inverter. The use of the inverter in the presence of flammable vapours or gases can lead to explosions. The inverter housing can become very hot under operation. Follow the instruction to provide gaps from both sides and top for adequate cooling. Direct sunlight on the inverters must be avoided. The inverter must be safely accessible to avoid accidents during maintenance work. | | | |

| Component | Inverter | | | PVFS 4-2vs.01 |
|---|--|--|---|---|
| | Dismount the component and follow the installation procedure. | Follow the given installation procedure, use of adequate cooling technology, perform regular inspections of the ventilation units. | | Monitoring of inverter temperature. |

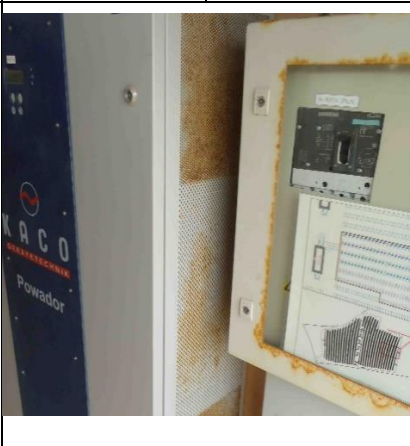
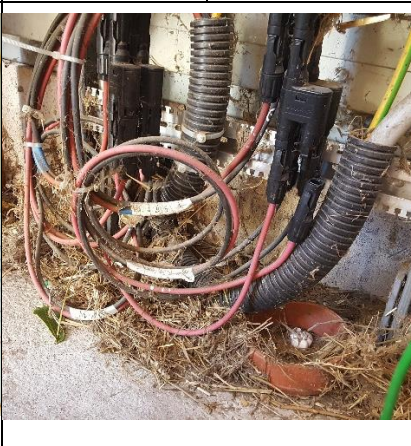
| <p>Examples 4-5</p> | | | | | | |

| | <p>Housing not appropriate. [TUV Rheinland]</p> | | <p>Presence of inflammable material. [SUPSI]</p> | | | |

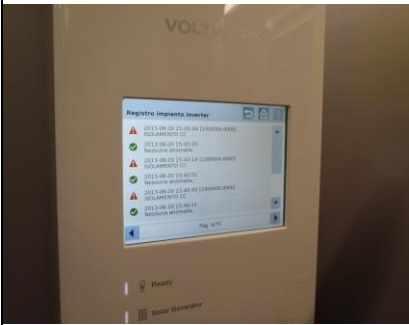
Examples
1-3

| Component | Inverter | | | PVFS 4-3vs.01 |
|---|---|--|---|--|
| Origin | A complete failure of the inverter occurs due one or more malfunctions of single hardware or software component of the inverter or faults due to grounding issues, e.g. high humidity inside the inverter, or a firmware issue. | | | |

Insulation failure. [TUV Rheinland]

| Component | Inverter | | | PVFS 4-3vs.01 |
|---|---|--|---|--|
| | Restart the inverter. Replace the components with defect or abnormal temperature. Update the software. | Use IRT and VOC to check the components and connection to find poor connection or defect components. | | |

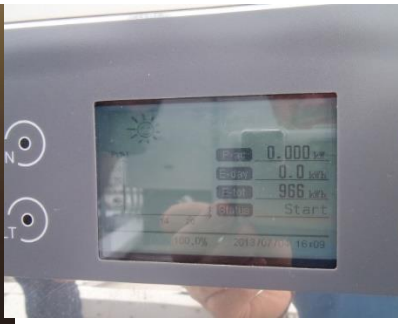
Not operating inverter. [TUV Rheinland]

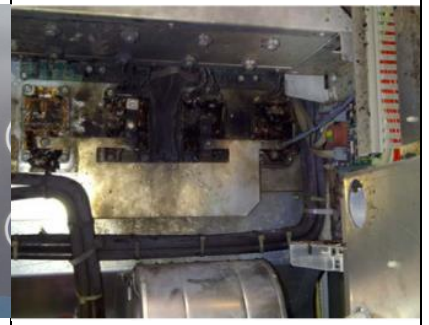
Damaged hardware component. [Sinclair17]
