Component	Module		PVFS 1-6vs.01
Defect	Backsheet chalking (whitening)		
Appearance	White powder is detectable on the external surface of the backsheet. It can be seen by passing a finger over the backsheet. It can be removed. The backsheet has usually a rough or dull appearance.		
Detection	VI		
Origin	Chalking is caused by the photothermal degradation of the polymers in the outer backsheet layer containing inorganic pigments. For example, TiO <sub>2</sub> pigments are often used in the outer layers as UV blocker.		
	Production <input checked="" type="checkbox"/>	Installation <input type="checkbox"/>	Operation <input checked="" type="checkbox"/>
Impact	Chalking does not affect module safety or performance on first sight, but it can be a sign for an ongoing degradation of the backsheet and a precursor for severe backsheet cracking. Due to the degradation-induced reduction of UV protection, more serious failures, such as <b>backsheet cracking</b> and <b>insulation failures can occur</b> . Enhanced moisture diffusion into the encapsulant/active PV-parts can lead to <b>corrosion</b> of cells and connectors, having a negative impact also on the performance.

Component Defect	Module	PVFS

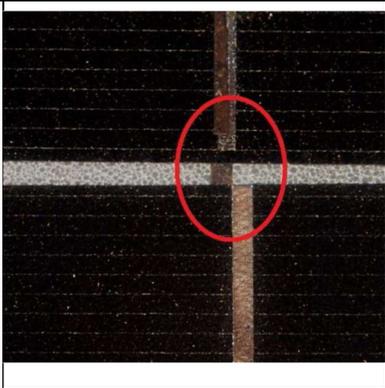
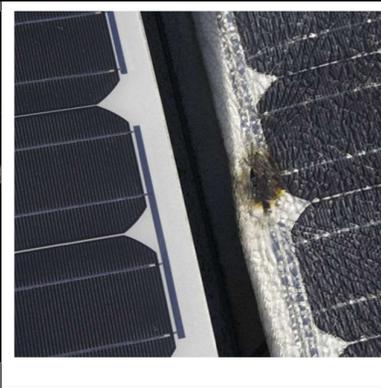
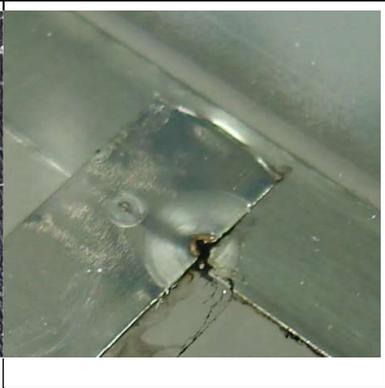
<p>Examples 4-6</p>

Component Defect	Module <b>Cell interconnection failure</b>		<b>PVFS 1-9vs.01</b>
Appearance	Weak or broken cell or string interconnection are not easy to see by the naked eye. The failure can be identified as dark region in the electroluminescence image where the failed interconnect would otherwise be collecting carriers or as a <b>hot spot</b> in the infrared image. In a progressed stage <b>burn marks</b> and <b>glass breakage</b> can occur.		
Detection	EL, IRT, STM, (VI)		
Origin	Typically, it is caused by the manufacturing process (e.g. poor soldering, misplacement of ribbons, too intense deformation of the ribbon kink, narrow distance between the cells) followed by thermomechanical stress or repetitive wind load caused by the outdoor operating environment. <b>Electrochemical corrosion</b> can be another cause for the degradation of interconnections.		
	Production <input checked="" type="checkbox"/>	Installation <input type="checkbox"/>	Operation <input checked="" type="checkbox"/>

Impact	Poor interconnections (soldering bonds) lead to an increase of contact resistance, higher power dissipation and localized heating. Broken connections are often associated with power loss, but if redundant electrical interconnections are available, a failed connection may have negligible effect on the power output. Safety risk may be not so high until the temperature of the induced <b>hot spot</b> does not increase to more than around 100 °C. If all busbars of a cell are interrupted, then the current flow in that string is completely blocked and an electric arc can result if the current is not bypassed by the bypass diode and the system operates at high voltage. The safety risk depends on the durability of this bypass diode. A bypass diode, which is continuously active over days can be damaged and pass into open-circuit or short circuit state. As a result of an <b>open circuited diode</b> , the current goes through the failed cell string and generates heat at the disconnected position. Very high temperatures or an electric arc and may cause fire, open electrical conducting parts to the user and destroy the mechanical integrity of the module.

<p>Zoom of a broken cell interconnect. [Yang19]</p>	<p>EL image of a module with 3 cells with disconnected inter-connect ribbons. [Köntges14]</p>	<p>Disconnected cell interconnect with delamination. [Köntges17]</p>			
<p>Severity</p>

Performance:
Mitigation	Corrective actions	Preventive actions (recommended)	Preventive actions (optional)
	<b>Modules with a direct safety risk or a severity of 5 should be replaced.</b> Regular inspections should be done to monitor the status of the not replaced modules.	Check validity of IEC 61215 certification and BOM.	Regular system inspections.
