# ACHILLES

## Advanced Characterisation of Photovoltaics for Hail Resistance

Industry Day 2026  
Mauro Caccivio, Dominika Chudy,  
21.05.2026, Mendrisio

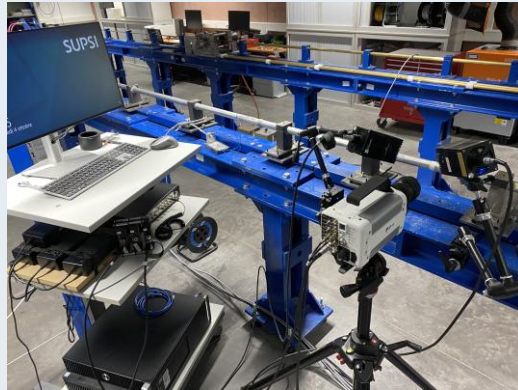
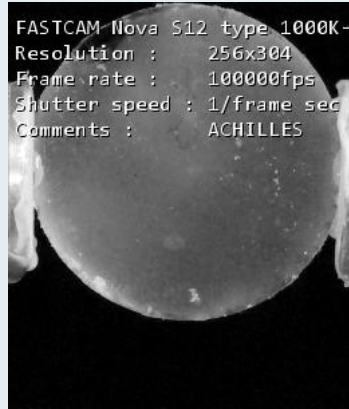
## 1 Static and dynamic characterisation of ice properties

FASTCAM Nova S12 type 1000K-  
Resolution : 256x304  
Frame rate : 100000fps  
Shutter speed : 1/frame sec  
Comments : ACHILLES

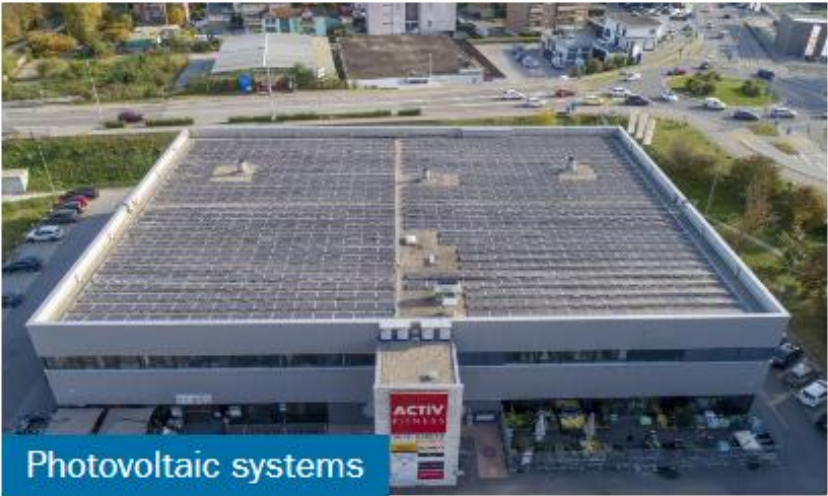
- 7 modules selected
- Module production year: 2013-2015
- PV system installation: 2014 – 2024

| Module<br>nameplate<br>parameters | Front<br>glass | Back | s<br>glass<br>[mm] | Pm<br>[W] | Vmp<br>p [V] | Impp<br>[A] | Voc<br>[V] | Isc<br>[A] | Eff<br>[%] |
| | Tempered | Tedlar | 3.2 | 260 | 30.6 | 8.50 | 38.2 | 9.00 | 15.9 |

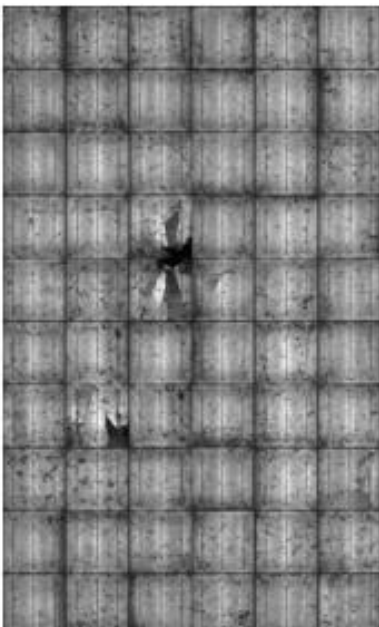
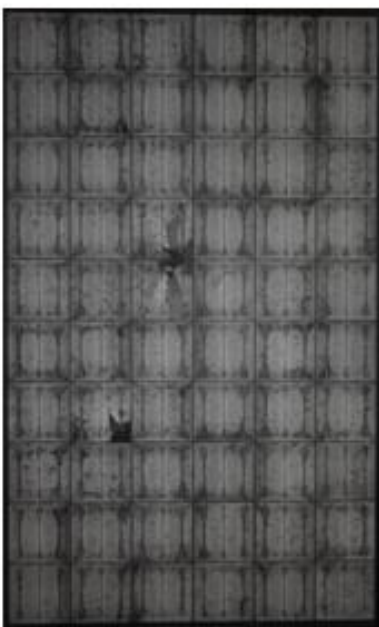
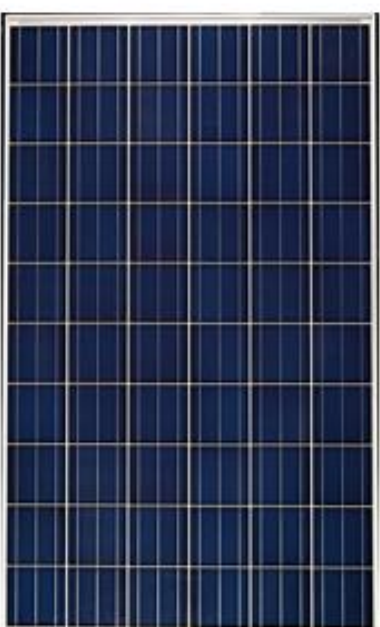
Module with concentrated impact

| PRE TESTING<br>METHODOLOGY_SUPSI | POST CYCLING MECH<br>LOAD_OST | POST TC + HF_OST | POST ALL _SUPSI | POST ALL_UV_SUPSI | POST ALL_VISIBLE_SUPSI |

Characterisation: EL, IV, UVF, Visual inspection
